FULL RESERVE STUDY

Granville Beach Condominium Association

Chicago, Illinois

June 7, 2016

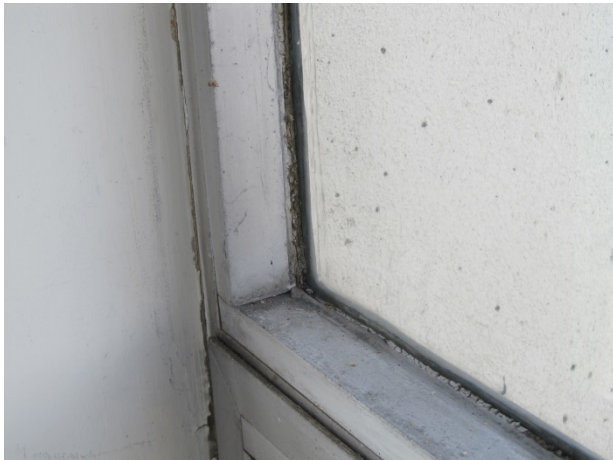
Seal failure at unit window

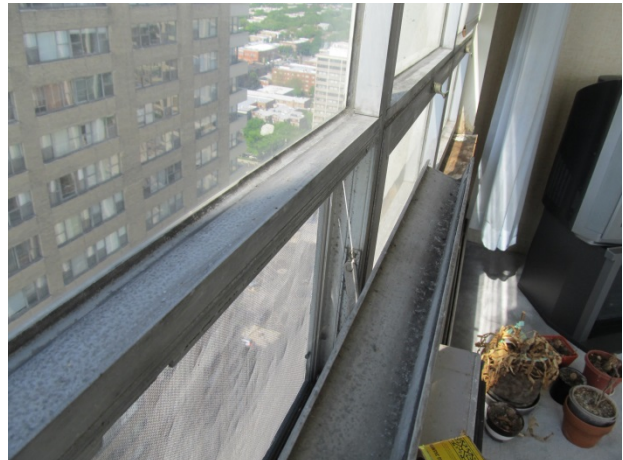
Lack of a gasket at hopper window

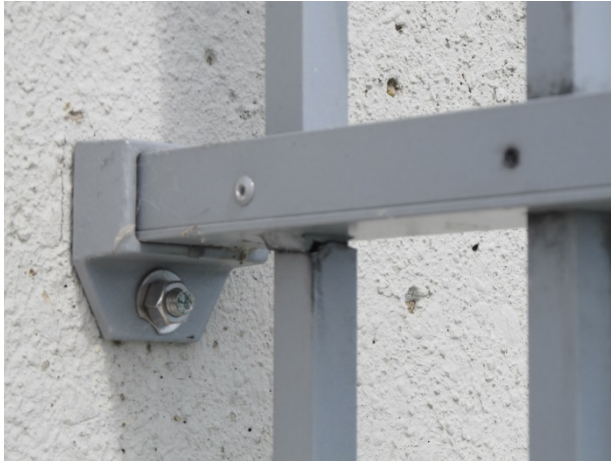
Railings, 29th Floor Roofs – The 29th floor east and west roofs include approximately 330 linear feet of prefinished aluminum railings. The railings were replaced in 2010. The Building Engineer informs us of excessive vibration of the railings resulting in damaged pickets and loose fasteners.

Railing damage

The railings have a useful life of up to 35 years. However, based on the conditions we include an expenditure for their replacement by 2020. We recommend the Association ensure proper design of the railing system to account for wind loads and the location. We also recommend the Association consider installation of prefinished steel railings. We note this information on Line Item 1.273 of *Reserve Expenditures*.

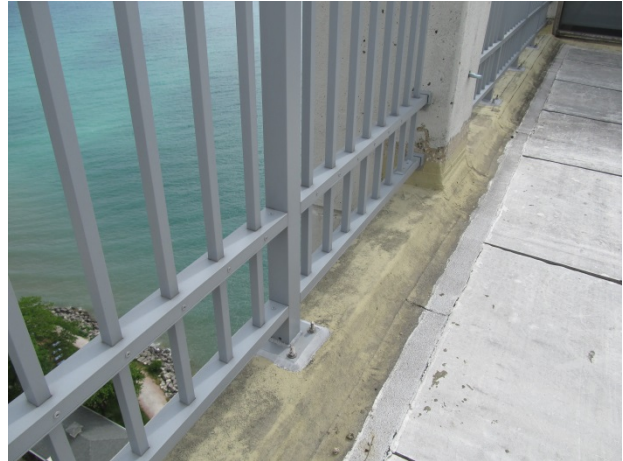
Railing at mount

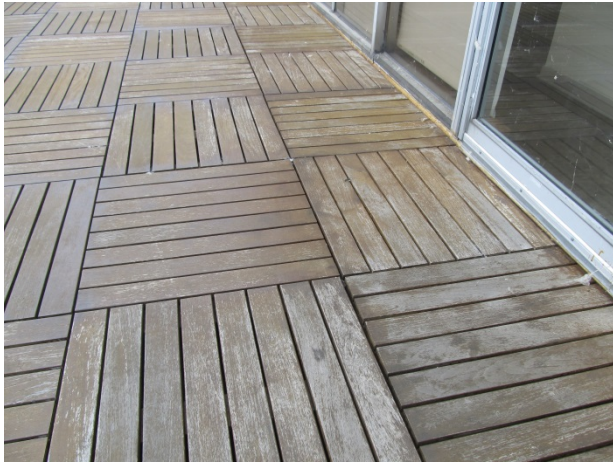
Roof, 29th Floor East, Membrane and Sun Deck – The 29th floor east roof area comprises approximately 27 squares of flat membrane roofing with a wood sun deck. The roof system and sun deck were replaced in 2010. The sun deck exhibits areas of finish deterioration.

Sun deck wood finish deterioration

The sun deck wood and underlying roof system has a useful life of 15- to 20-years. We assume timely stain applications to the wood decking through the operating budget. We include an expenditure for replacement of the sun deck wood and roof system by 2028 and again by 2046. We note this information on Line Item 1.531 of *Reserve Expenditures*.

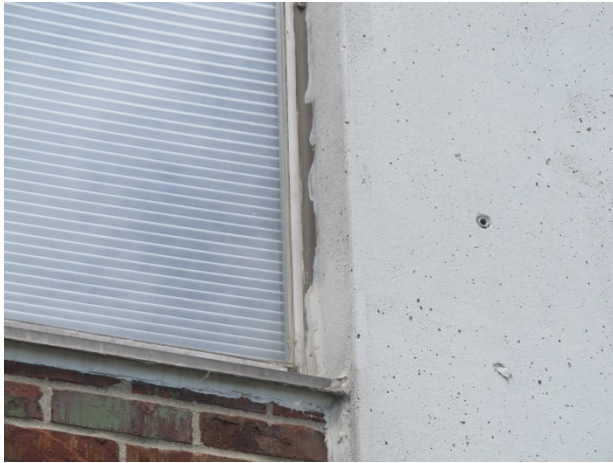
Varied sealant conditions at metal/concrete interface

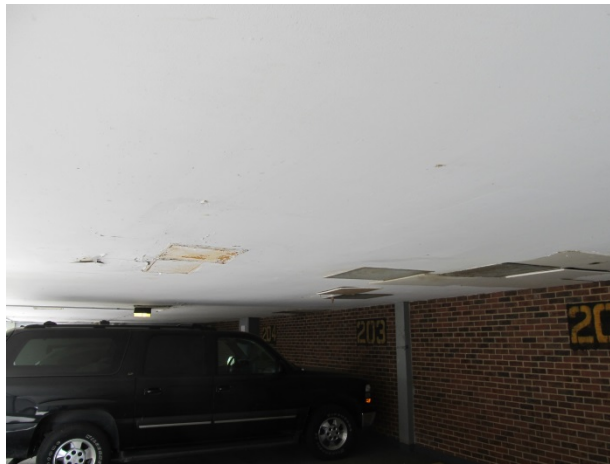
Soffits – The building includes approximately 7,000 square feet of finished soffits at the 2nd floor parking areas and lobby entrance area. The soffits exhibit areas of damage, finish deterioration and previous repairs.

Previous repairs at soffit

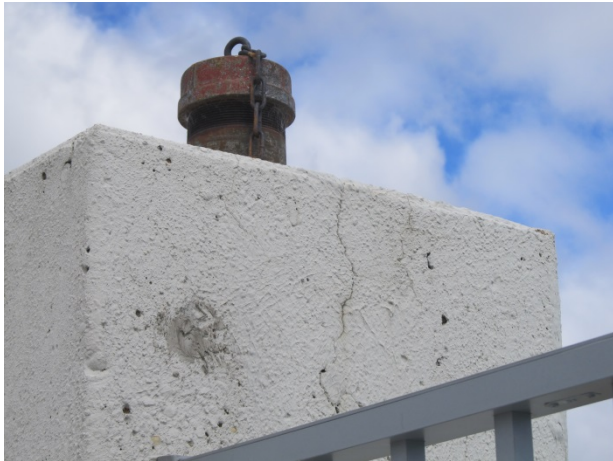
Walls, Concrete - The Granville Beach exterior includes 47,000 square feet of concrete structural members and façade with a coating application. The Association completed concrete repairs in 2011. The coating likely dates to 2003 to 2005. We note a significant amount of previous repairs, areas of unrepaired cracks and coating deterioration.

Concrete crack

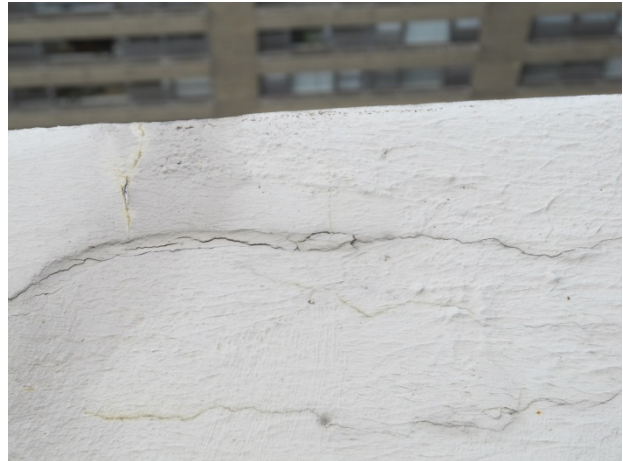
Concrete crack

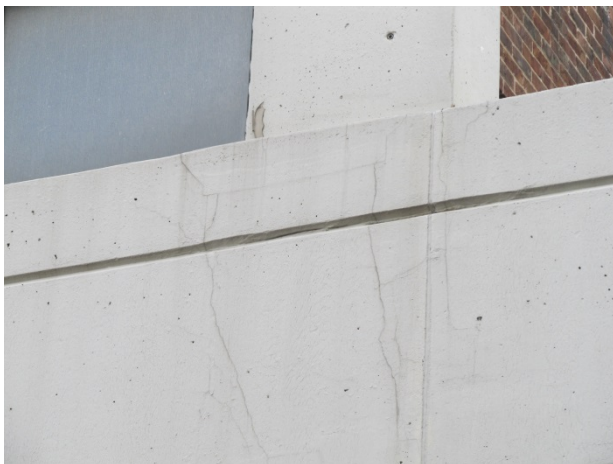
Concrete cracks

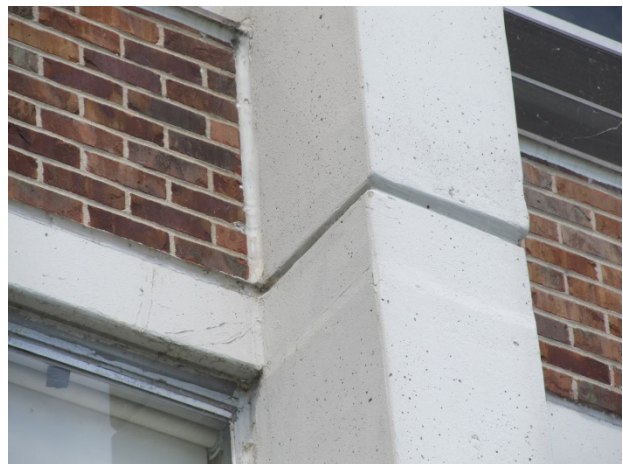
Previous concrete repairs

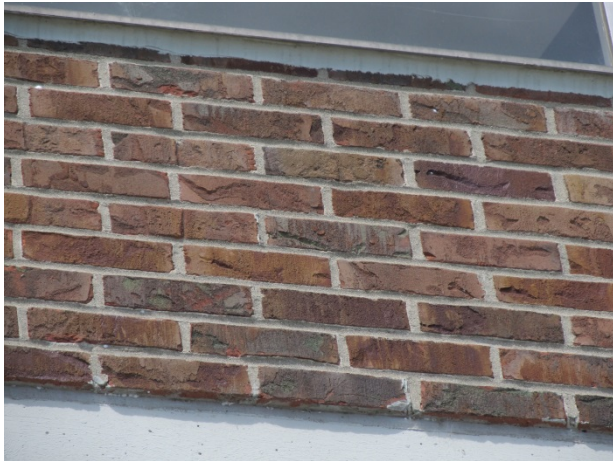
Tower masonry joint condition

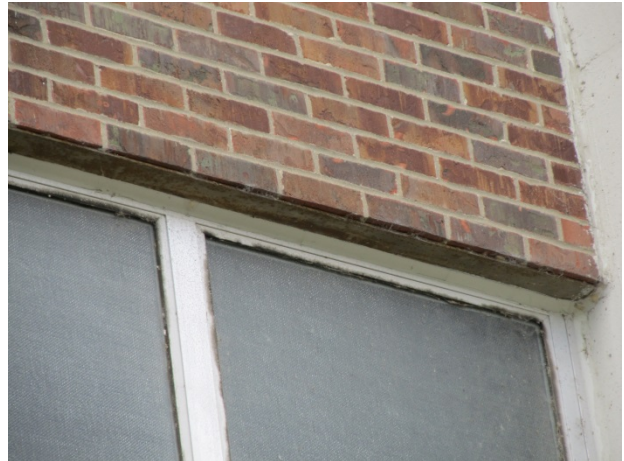
Rust at shelf angle and lack of flashing

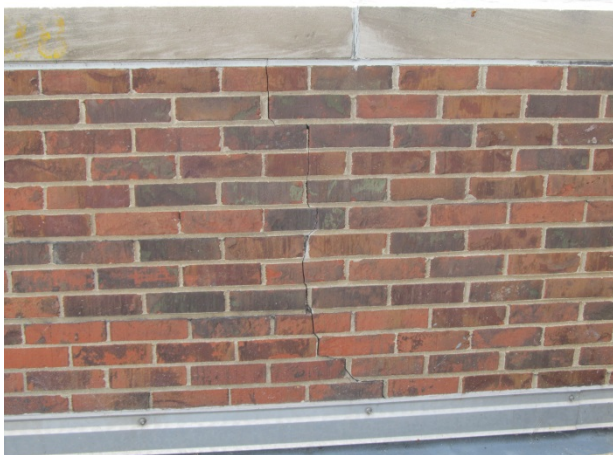
Crack in masonry at parapet wall at base structure

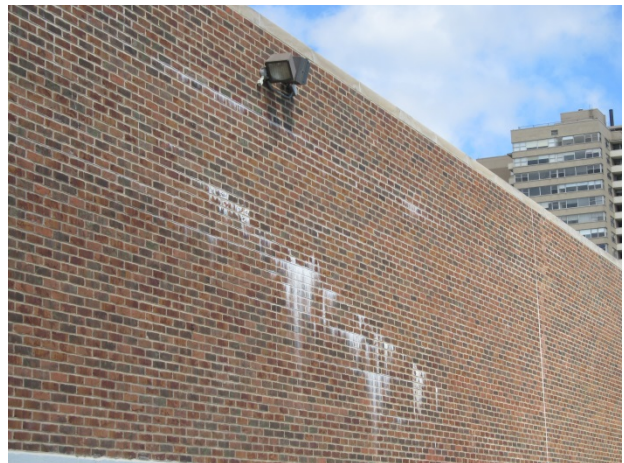
Efflorescence at base structure at east elevation

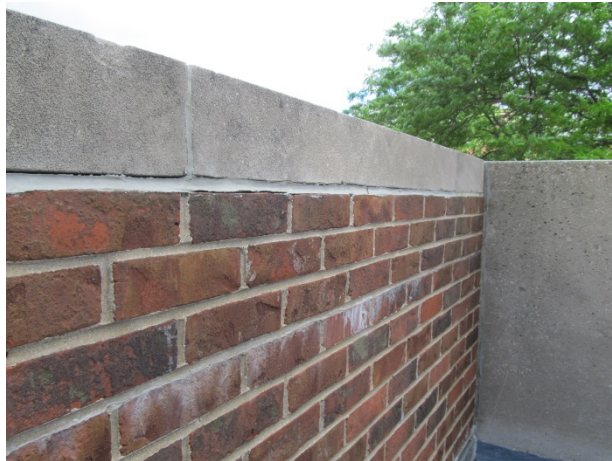
Lack of flashing beneath cap and efflorescence at base structure

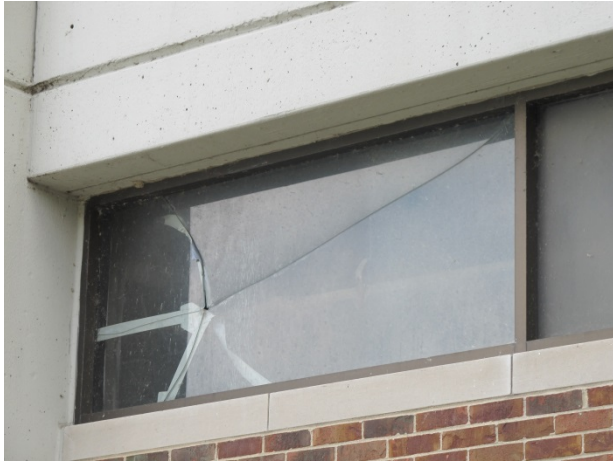
Cracked common window at garage

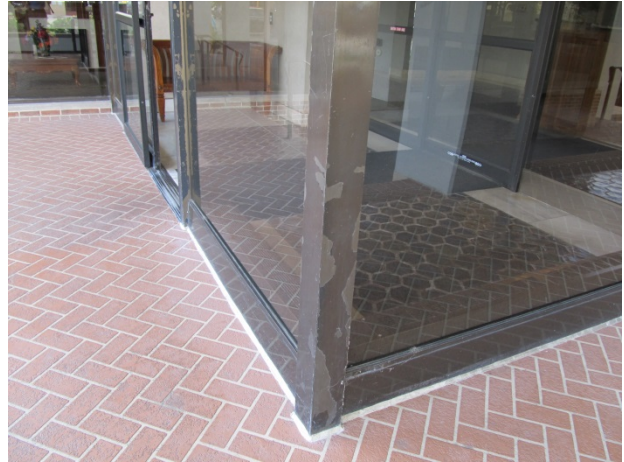
Finish deterioration at lobby window system

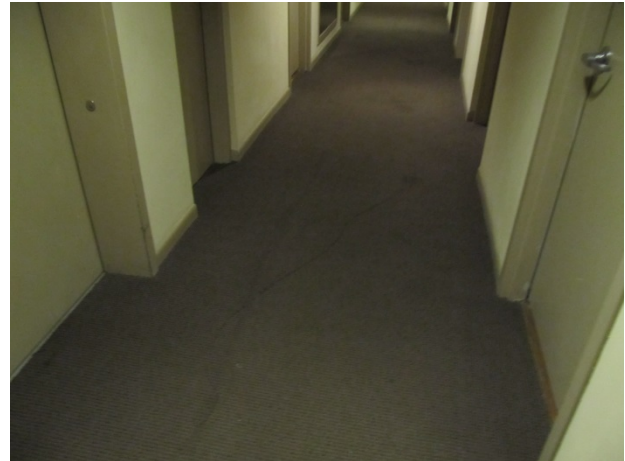
Floor Coverings, Carpet, Hallways - Carpet comprises 2,100 square yards of the common area hallway floor coverings. Contractor measurements will vary from the actual floor area due to standard roll lengths, patterns and installation waste. The carpet was replaced in 2011 and is in fair condition. We note stains and deterioration at seams.

Stains at carpet

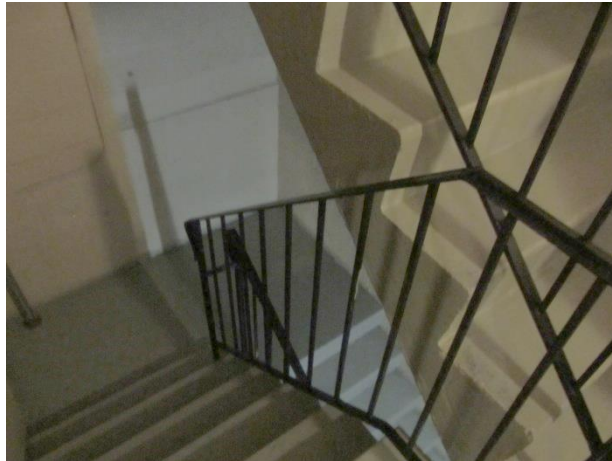
Paint Finishes, Stairwells - In addition to the hallway paint finishes, the Association maintains the paint finishes in the two stairwells. The paint finish exhibits areas of scuffs and damage.

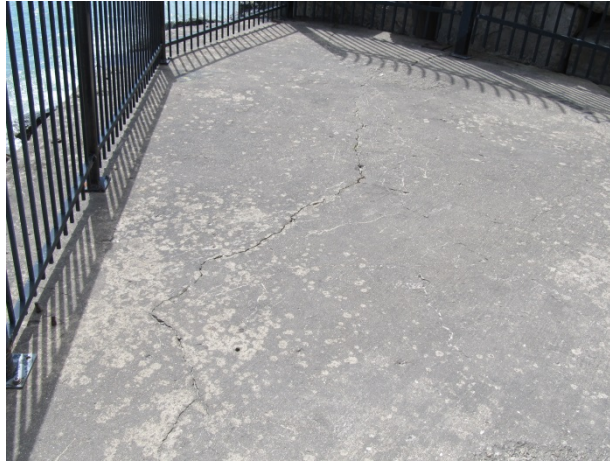
Fishing Pier – The development includes a fishing pier at the east perimeter. The pier comprises concrete with a perimeter metal fence. The concrete exhibits areas of cracks and deterioration. The fence exhibits areas of damage.

Fishing pier concrete cracks

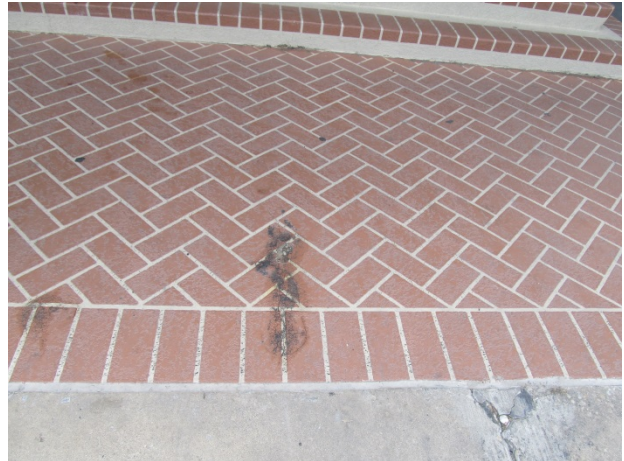
Concrete deterioration at lobby entrance area

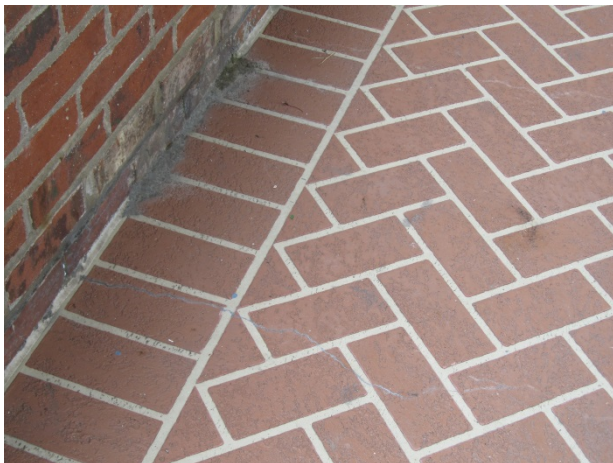
Cracks in concrete/coating at west perimeter

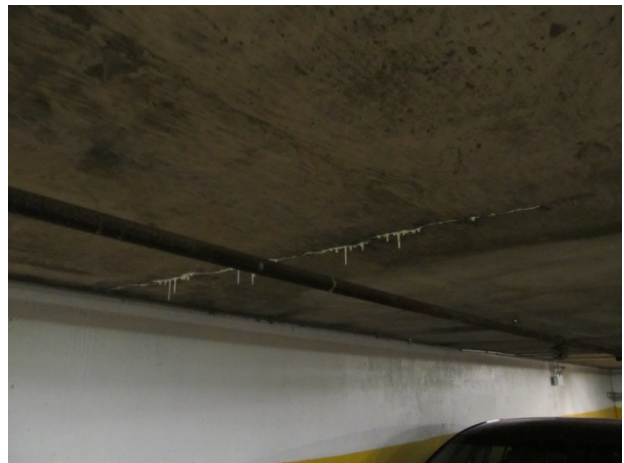
Evidence of water infiltration beneath west perimeter vaulted concrete

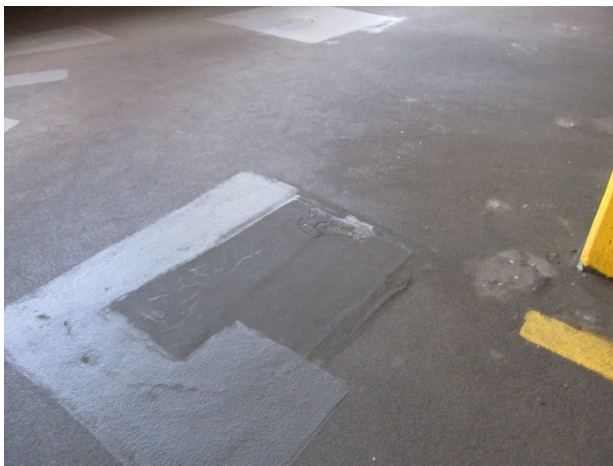
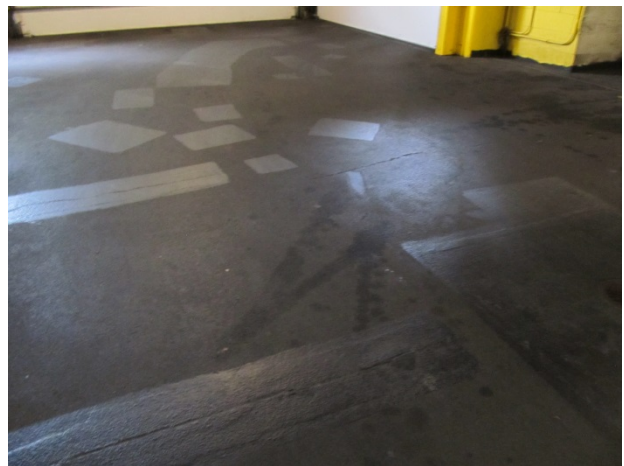
Numerous traffic coating repairs and areas of coating deterioration at 1st floor

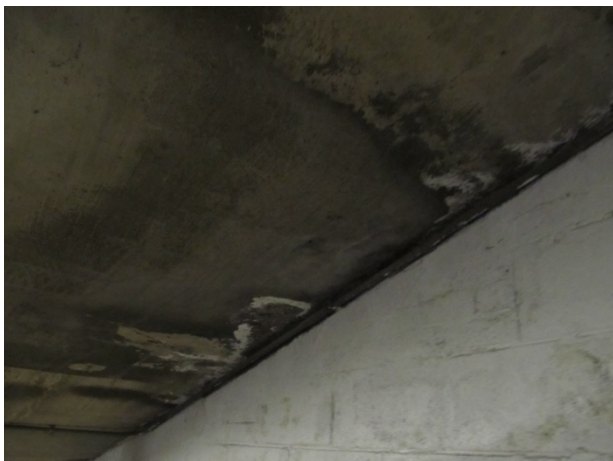
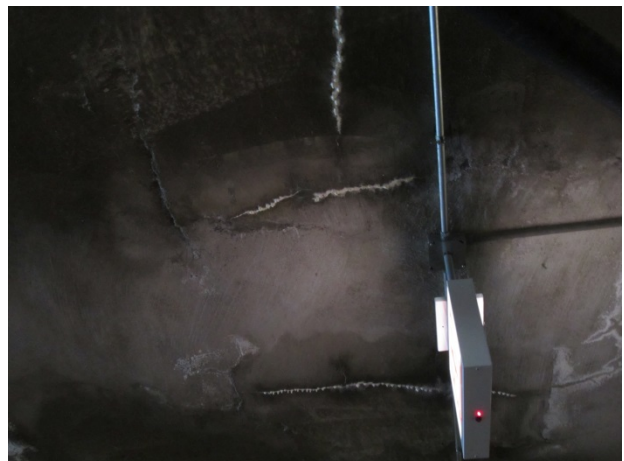
Evidence of water infiltration beneath 2nd floor garage level

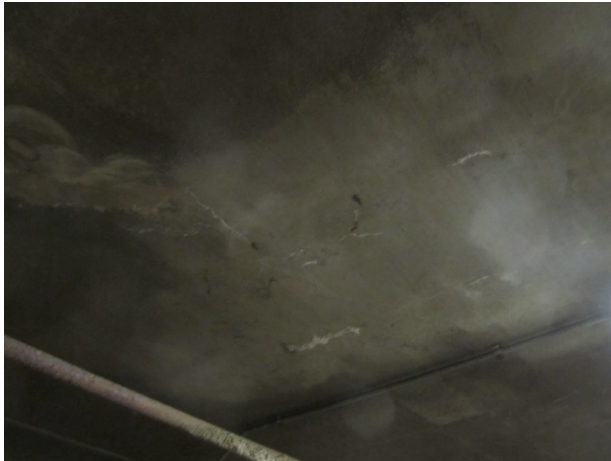
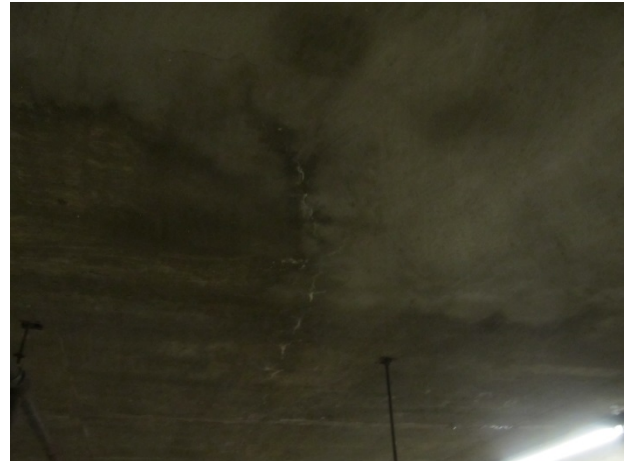
Evidence of water infiltration beneath 1st floor garage level

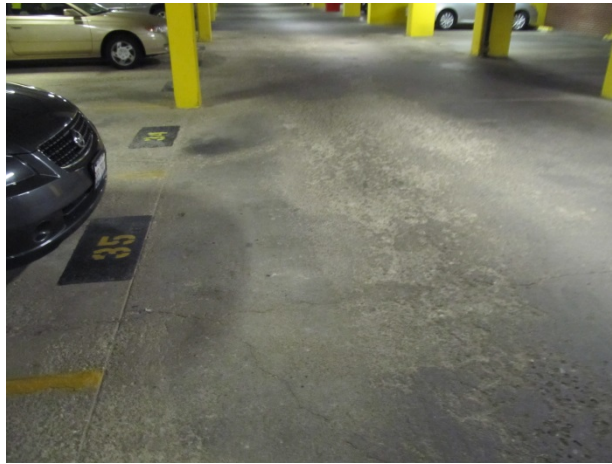
Concrete, On-grade - Granville Beach maintains approximately 22,000 square feet of on-grade concrete at the basement level garage. The concrete exhibits cracks and surface spall.

Concrete surface spall and cracks at on-grade garage level
