**Revised**  
**FULL RESERVE STUDY**  
**Circle C**  
**Homeowners Association**

**Austin, Texas**

**Inspected - May 29, 2018**  
**Revised - September 21, 2018**

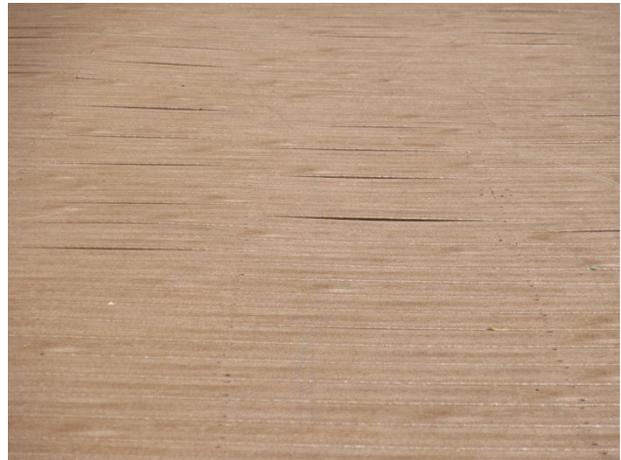
**Condition:** Good overall with sags and dips evident

Sag in composite deck boards

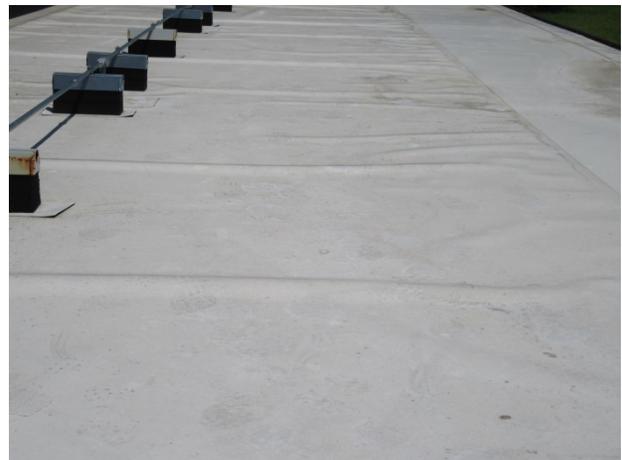
**Condition:** Good to fair overall with bulges in the membrane evident at the Community Center.

**Numerous ripples in the membrane**

Over time, exposure to ultraviolet light, heat and weather degrade the membrane. This degradation results in membrane damage from thermal expansion and contraction, adverse weather and pedestrian traffic. The aging process makes the membrane less pliable and more difficult to maintain. Ponding water on the roof can increase the effects of ultraviolet light on the membrane and contaminants in ponded water can

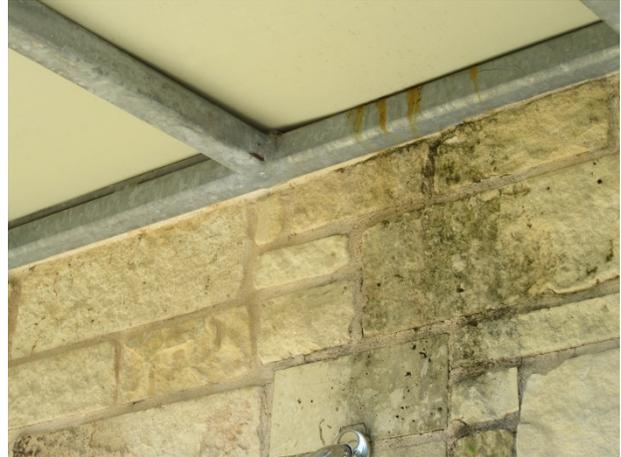
**Area of water damage**

**Useful Life:** The Association should anticipate inspection and repairs to the masonry every 8- to 10-years.

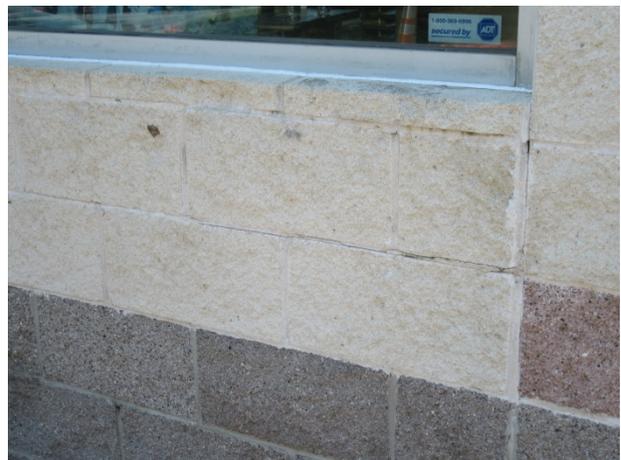
**Mortar deterioration beneath window at Swim Center**

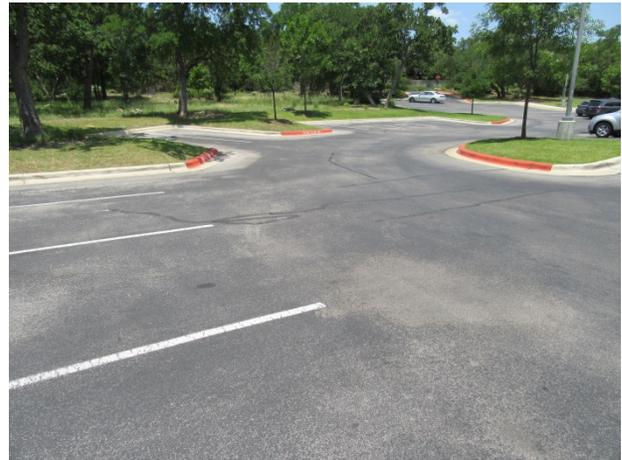
**Condition:** Good to fair overall with seal coat deterioration throughout the locations and fatigue cracks and previous repairs at the Swim Center evident

**Seal coat deterioration at the Community Center**

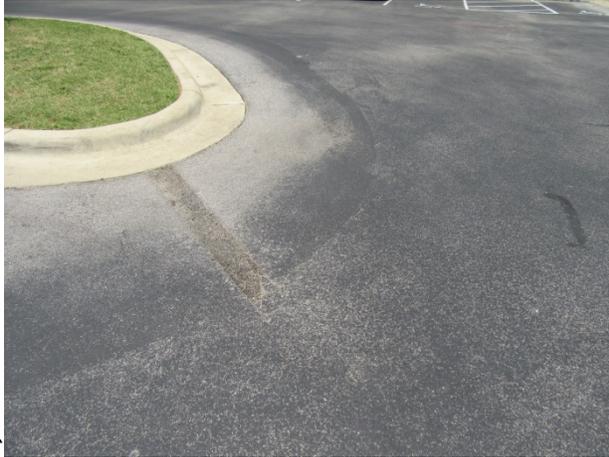
**Seal coat deterioration and cracks at the Community Center**

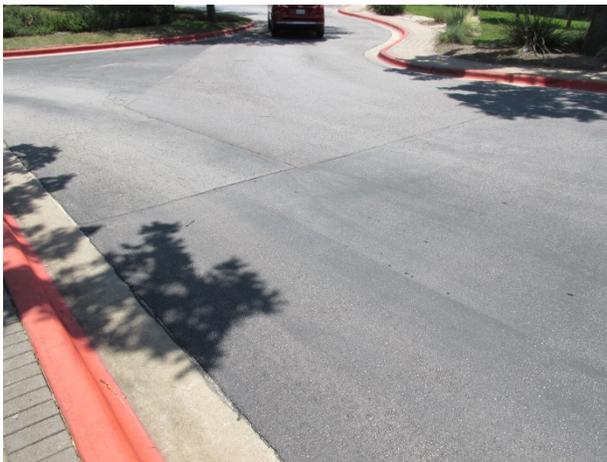
**Wear and general deterioration at the Swim Center**

The manner of repaving is either a mill and overlay or total replacement. A mill and overlay is a method of repaving where cracked, worn and failed pavement is mechanically removed or milled until sound pavement is found. A new layer of asphalt is overlaid atop the remaining base course of pavement. Total replacement includes the removal of all existing asphalt down to the base course of aggregate and native soil followed by the application of two or more new lifts of asphalt. We recommend mill and overlayment on asphalt pavement that exhibits normal deterioration and wear. We recommend total replacement of asphalt pavement that exhibits severe deterioration, inadequate drainage, pavement that has been overlaid multiple times in the past or where the configuration makes overlayment not possible. Based on the apparent visual condition and configuration of the asphalt pavement, we recommend the mill and overlay method of repaving at Circle C.

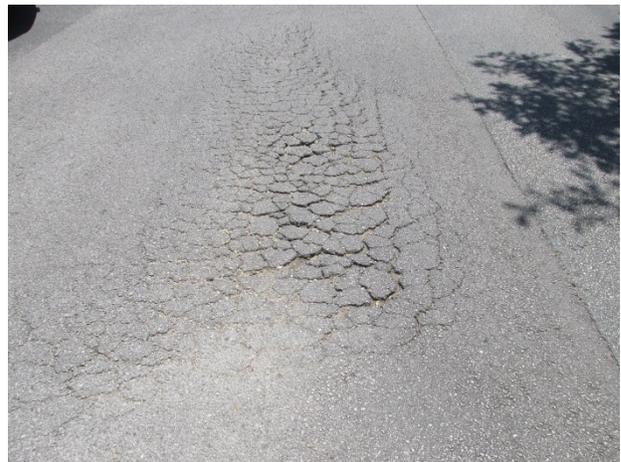
**Fatigue cracks at the Swim Center**

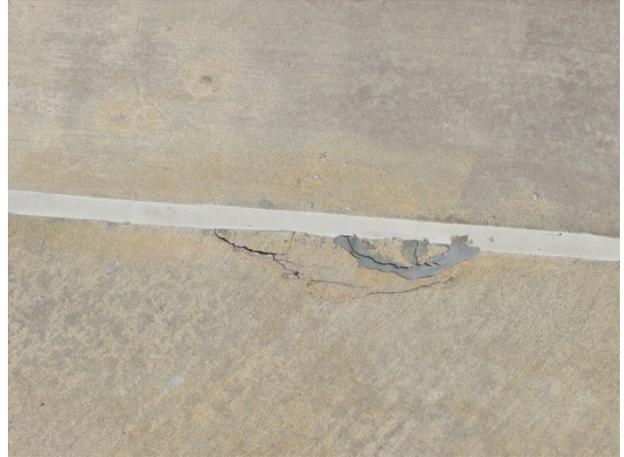
**Concrete deterioration**

**Useful Life:** The useful life of a concrete pool deck is up to 60 years or more with timely repairs. We recommend the Association conduct inspections, partial replacements and repairs to the decks at Avana, the Community Center and Grey Rock every 8- to 12-years. The masonry pavers at the Swim Center have a useful life of up to 25 years. We recommend the Association coordinate repairs to the concrete deck portion concurrent with resetting and partial replacement of the masonry pavers every 8- to 12-years.

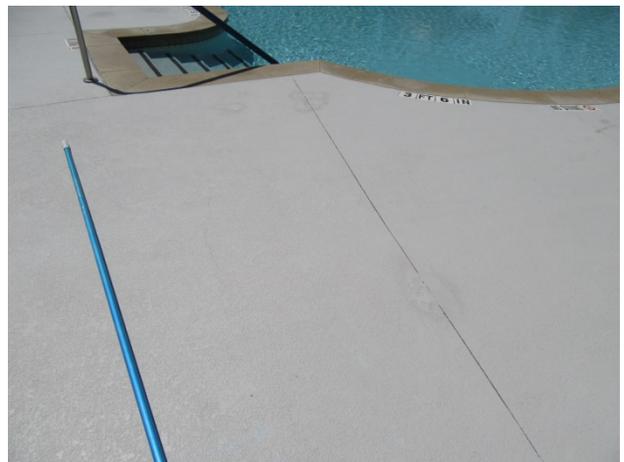
**Areas of repairs**

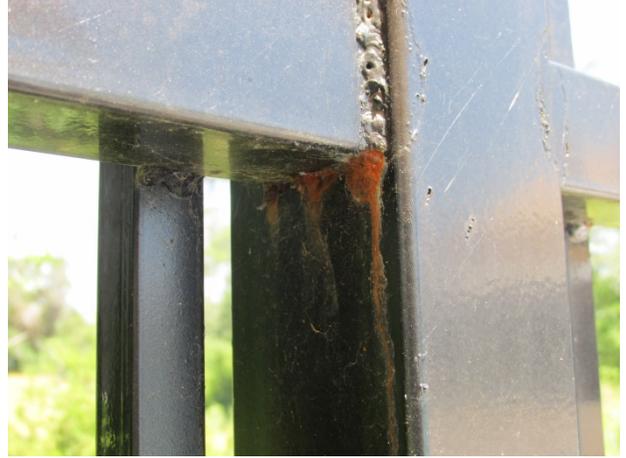
**Condition:** Good overall condition with isolated areas of rust and damage evident

**Isolated rust**

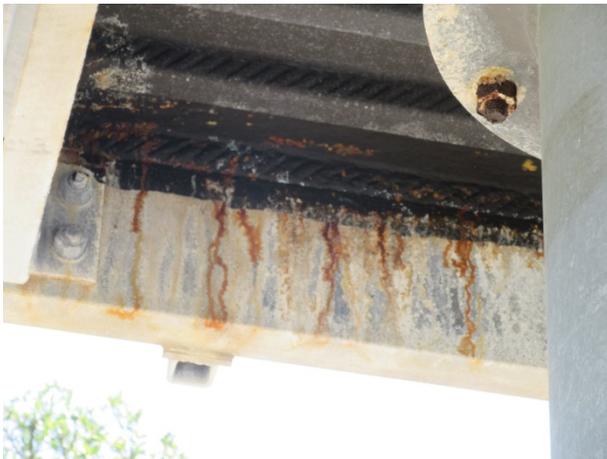
**Conditions:** Good overall with evidence of rust and minor deterioration

**Rust**

**Useful Life:** Replacement at up to 20 years and refinishing every five years
