# **FULL RESERVE STUDY**

## **Sunvalley Casitas Condominium Association**

**Mesa, Arizona**  
**January 3, 2022**

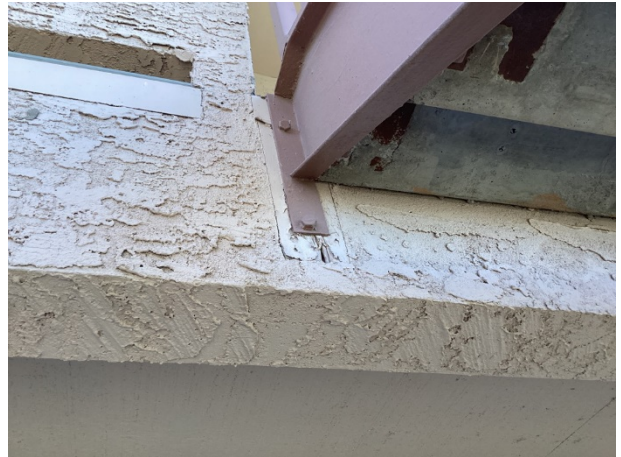
**Deterioration at fastener**

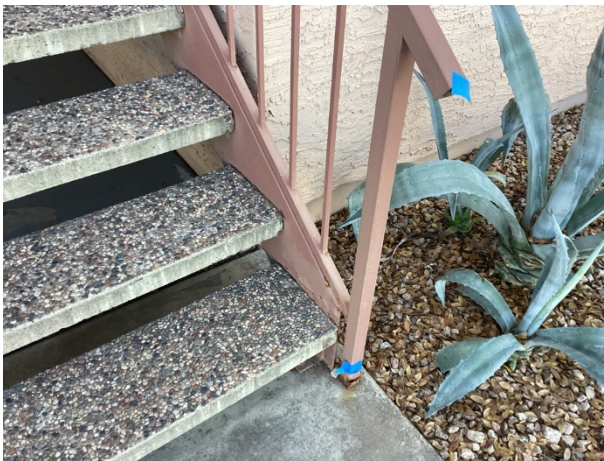
**Corrosion at Building 8**

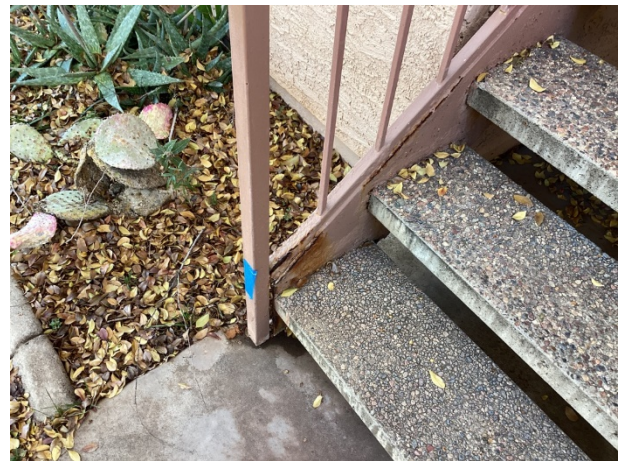
**Significant corrosion at Building 5**

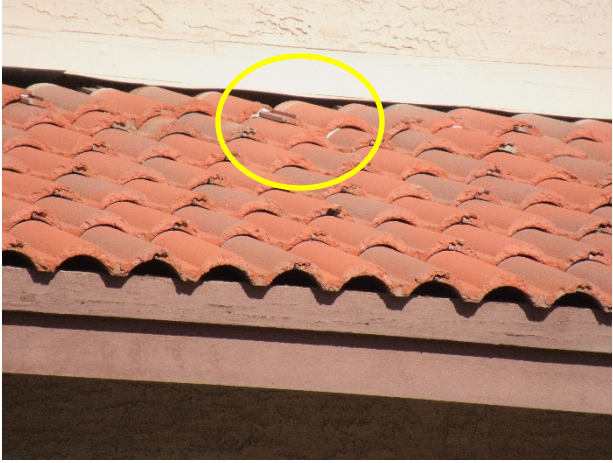
**Condition:** Fair overall with previous repairs, and chipped and loose tiles evident from our visual inspection from the ground. Management and the Board report a limited history of leaks and inform us the Association will obtain bids to replace in the near future.

**Previous repairs evident**

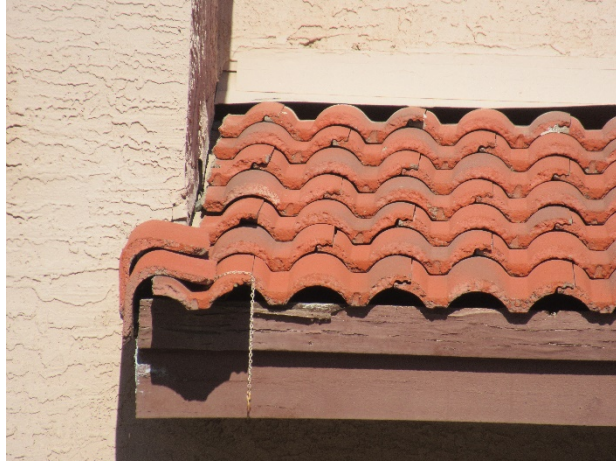
**Chipped tiles evident**

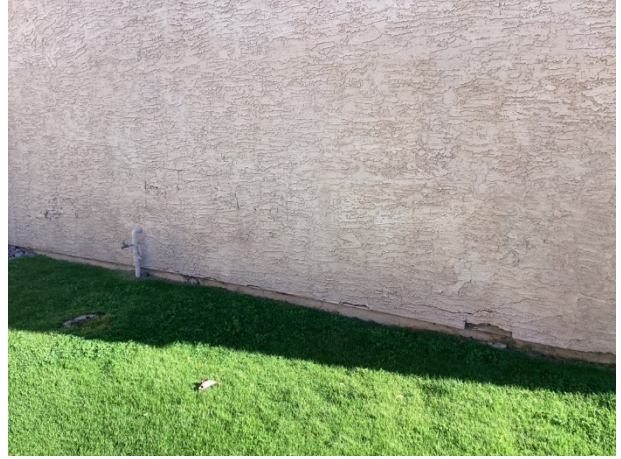
**Stucco cracks and peeling paint at cabana**

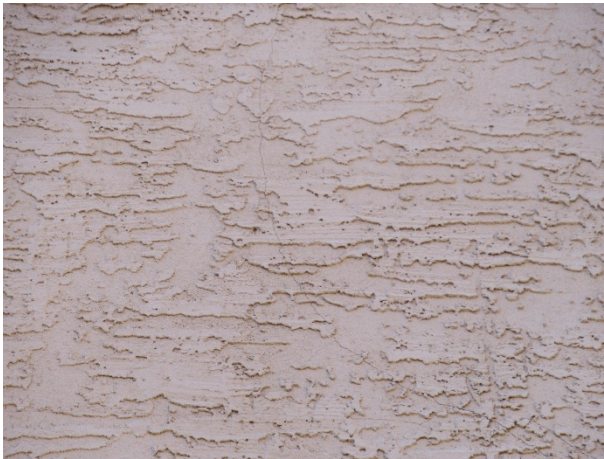
**Stucco crack**

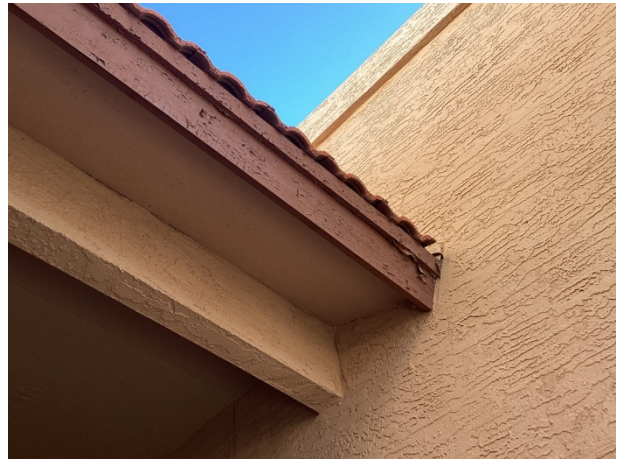
**Peeling paint at wood trim**

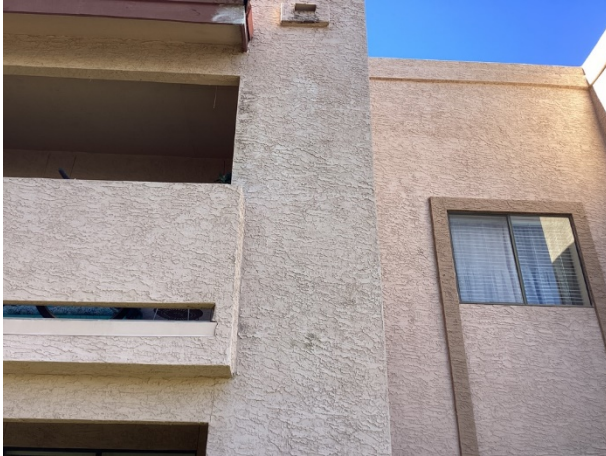
**Finish deterioration**

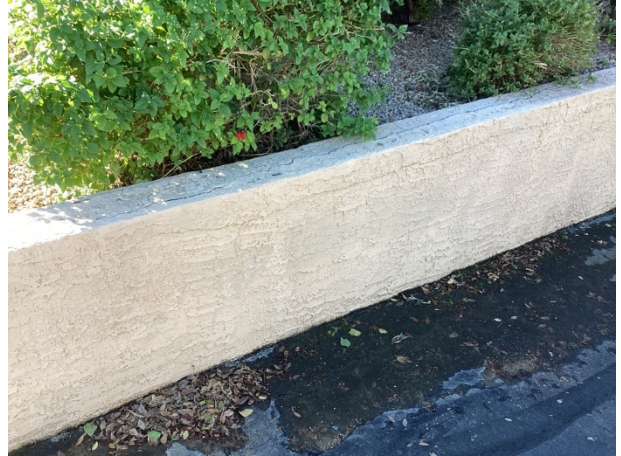
**Stucco cracks at retaining wall by Building 6**

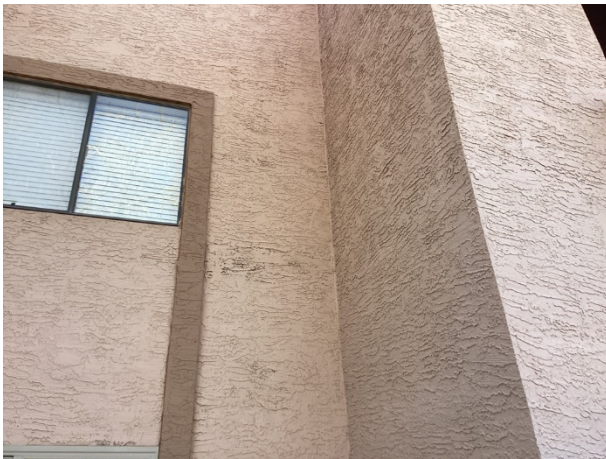
**Finish stains**

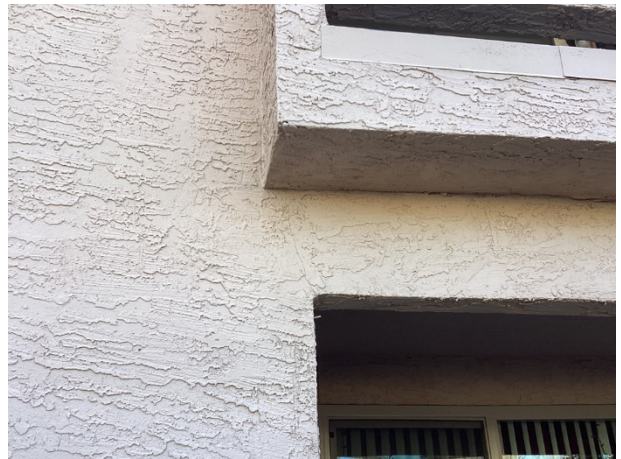
**Stucco crack**

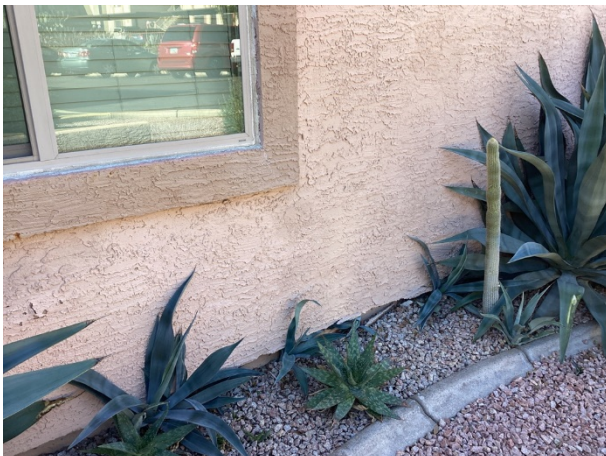
**Peeling finish**

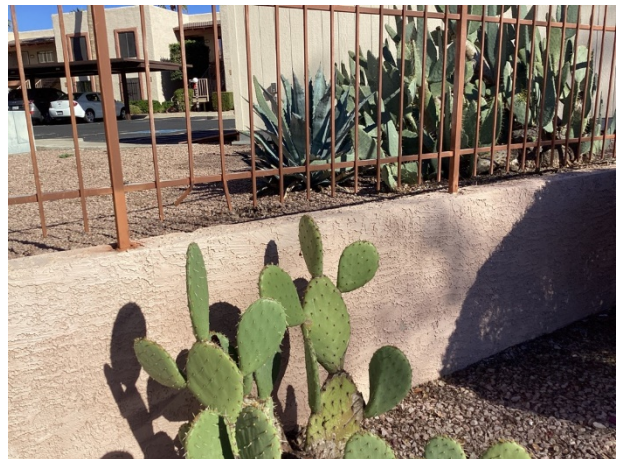
**Wall paint finish deterioration and damaged fence pickets**

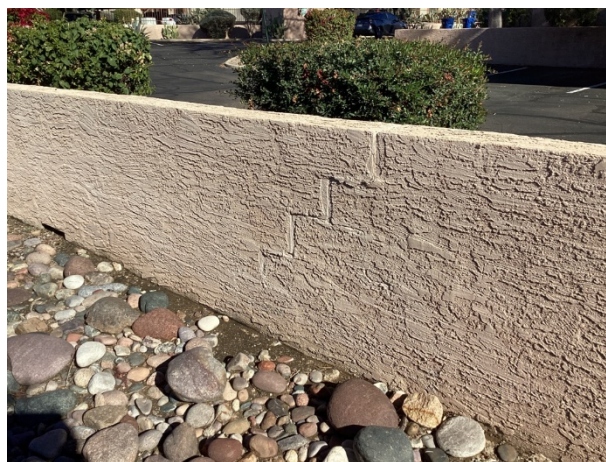
**Step crack at west perimeter wall**

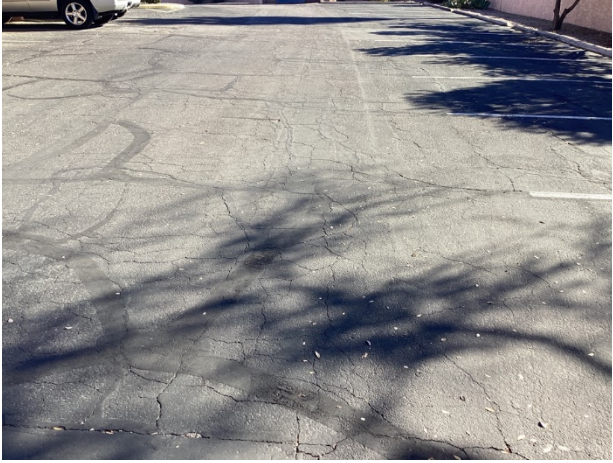
**Condition:** Fair to poor overall with frequent cracks, settlement, potholes, alligator cracks and raveling evident.

**Extensive pavement cracks**

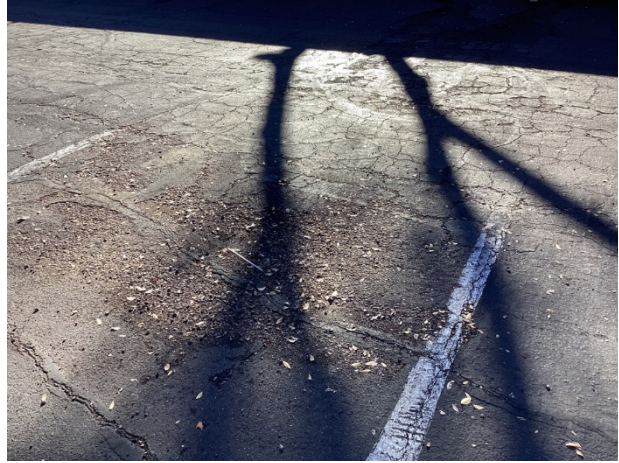
**Raveling pavement**

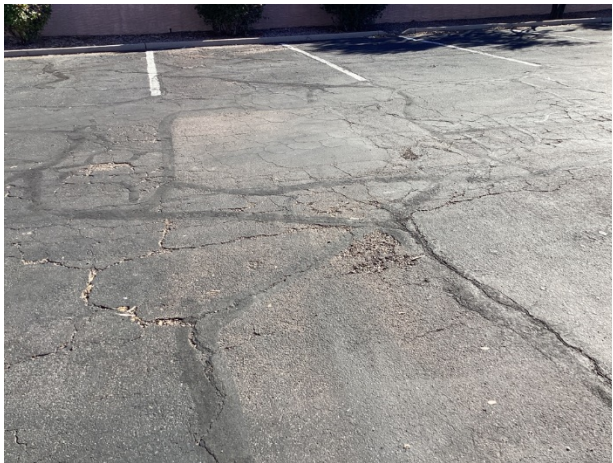
**Alligator cracks and potholes**

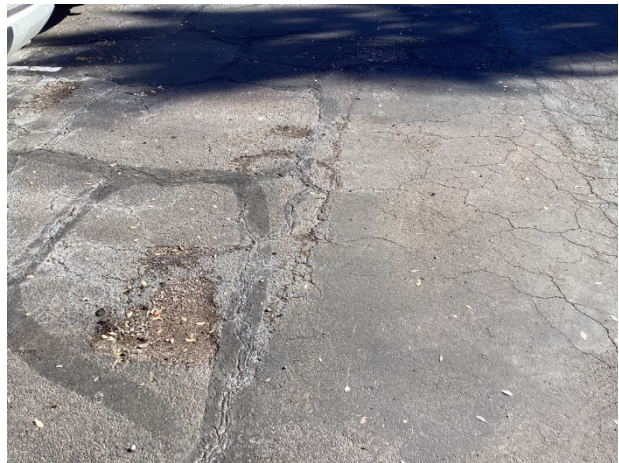
**Pavement pothole formation**

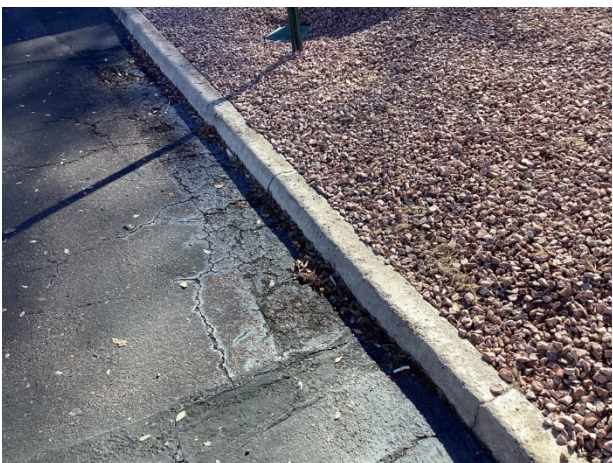
**Concrete curb spalls**

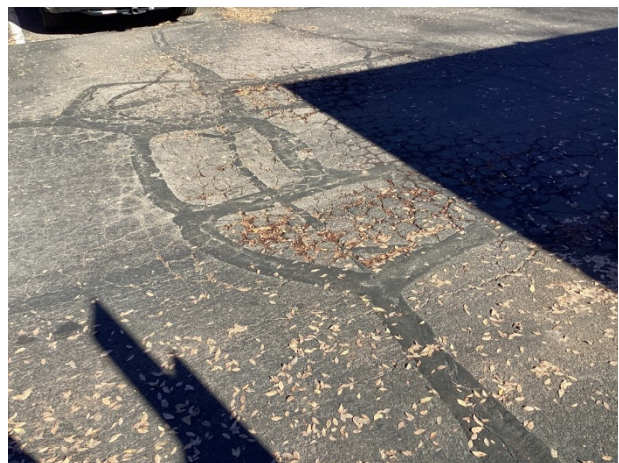
**Significant alligator cracks**

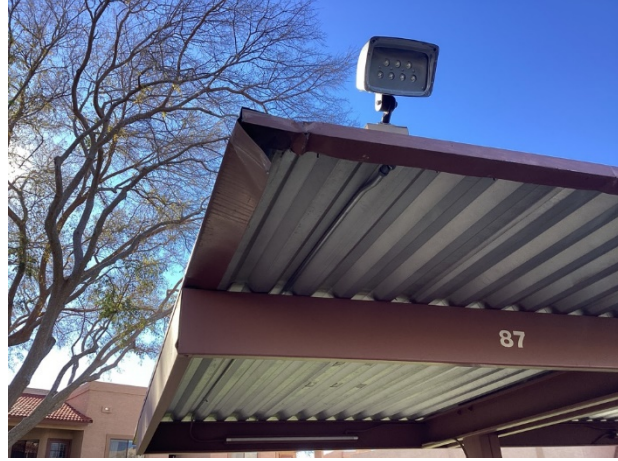
**Isolated damage**

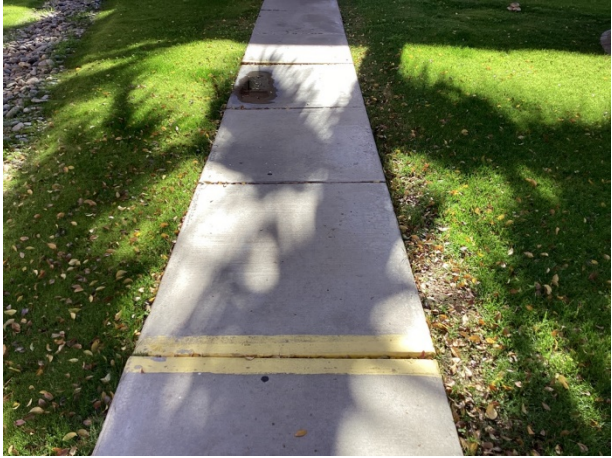
**Sidewalk settlement**

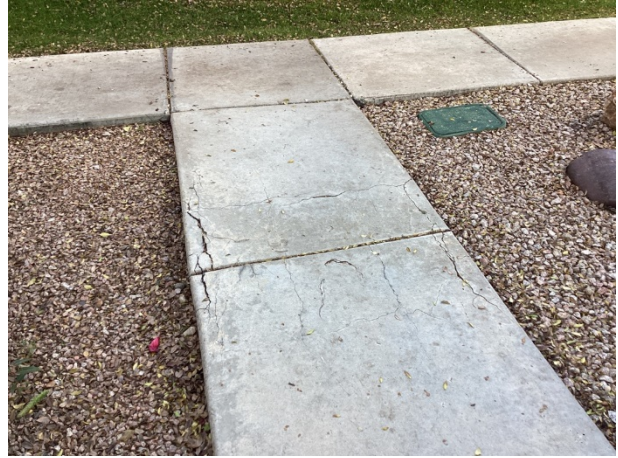
**Sidewalk cracks**

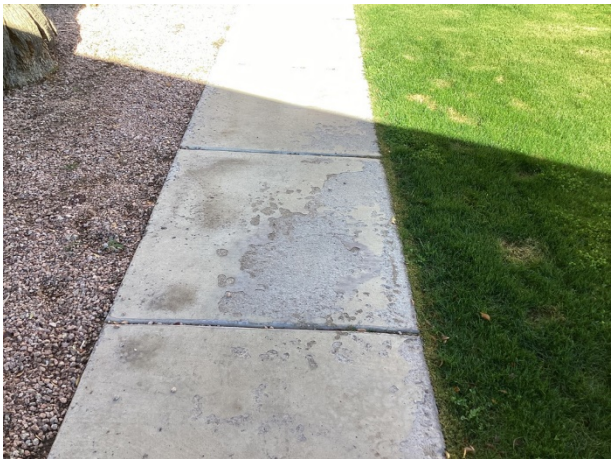
**Sidewalk spalls**

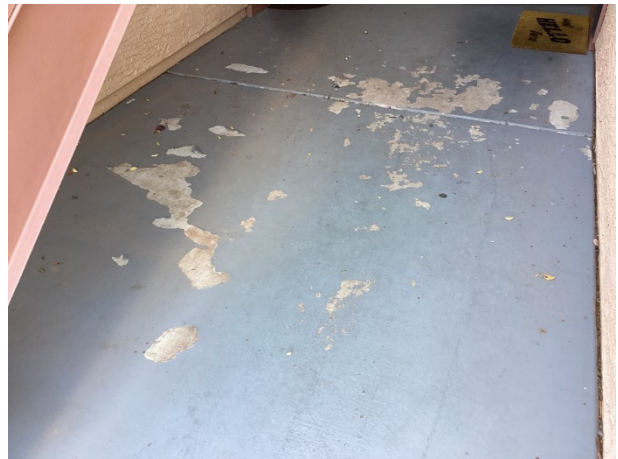
**Coating delamination at unit entrances**

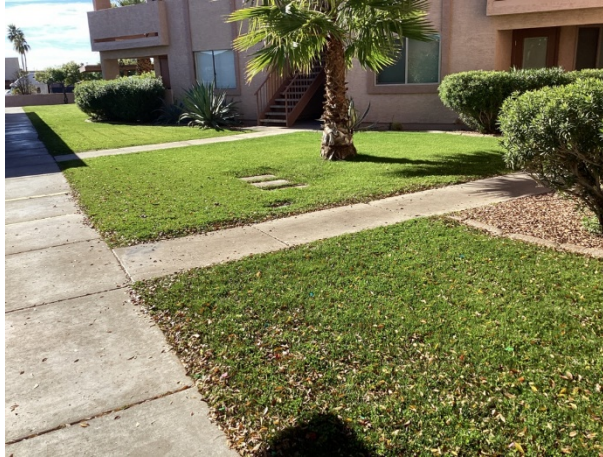
**Condition:** Unsatisfactory operational condition, and Management and the Board report under watered and over watered areas.

**Irrigated lawn area**

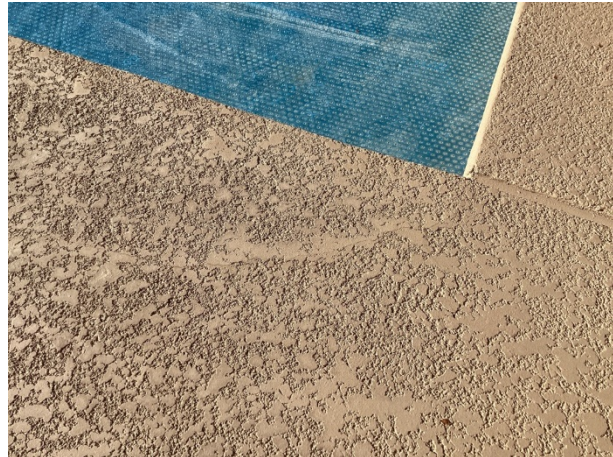
Minor crack

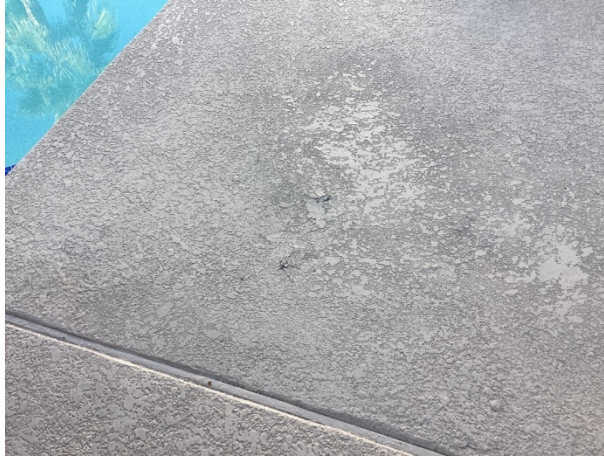
**Textured coating delamination**

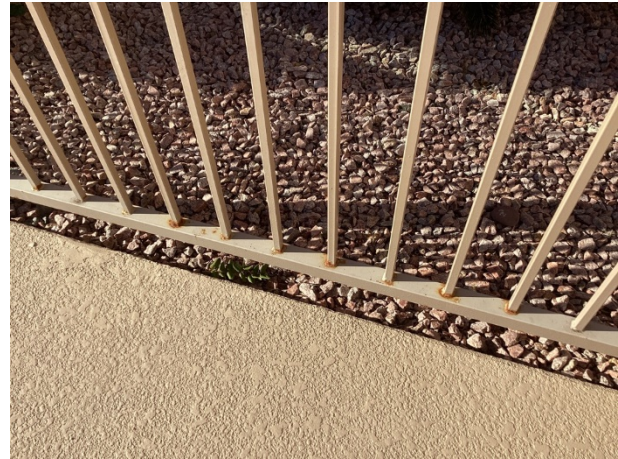
**Fence rust**

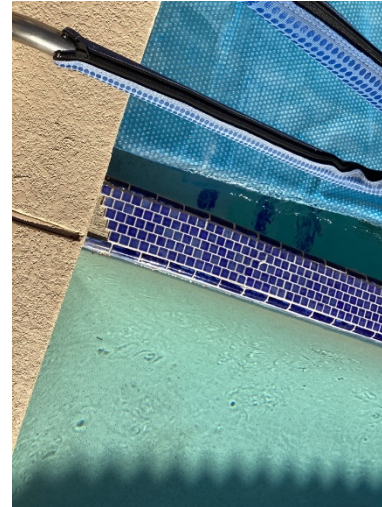
**Tile damage**
