FULL RESERVE STUDY

Granville Beach Condominium Association

Chicago, Illinois

June 7, 2016

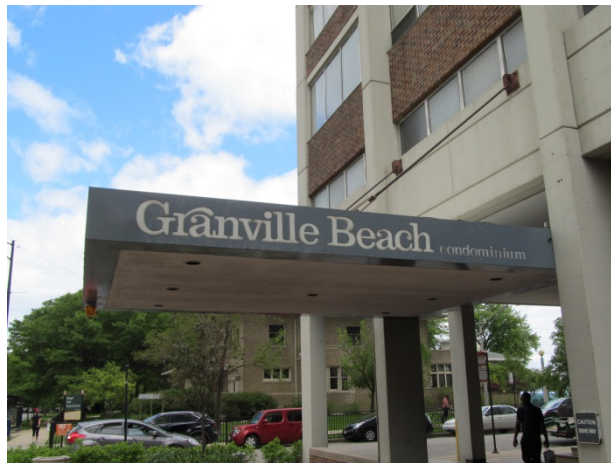
Lobby canopy

The Association replaced the roof in 2012. The canopy system has a useful life of up to 30 years. The desire to update the appearance of the front entrance area often warrants a redesign of the entrance canopy. We include an expenditure for its replacement by 2023. We recommend the Association conduct interim repairs and paint applications through the operating budget. We note this information on Line Item 1.130 of ***Reserve Expenditures***.

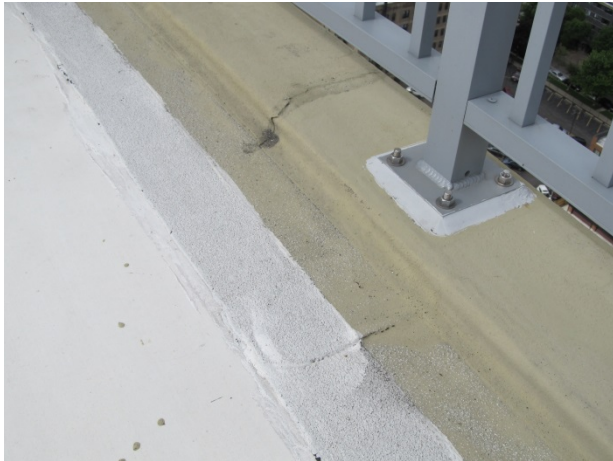
Roofs, Mechanical Penthouse and 29th Floor West, Thermoplastic - The mechanical penthouse and 29th floor west roofs at Granville Beach consist of 79 *squares*¹ of thermoplastic roofing. The roofs were replaced in 2009 are in good overall condition. The Building Engineer does not report a history of leaks. Our visual inspection notes membrane bulge, perimeter sealant deterioration and areas that lack drainage.

Roof system perimeter termination

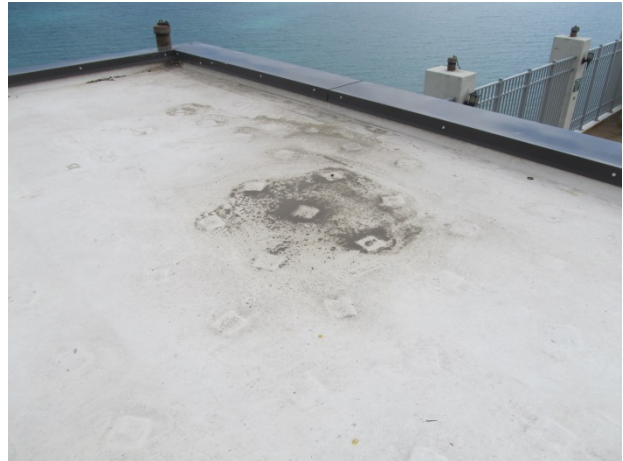
Evidence of lack of drainage at mechanical penthouse roof

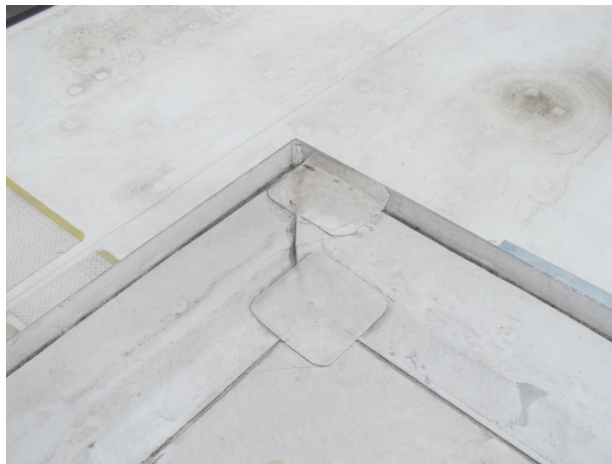
Roof system perimeter termination

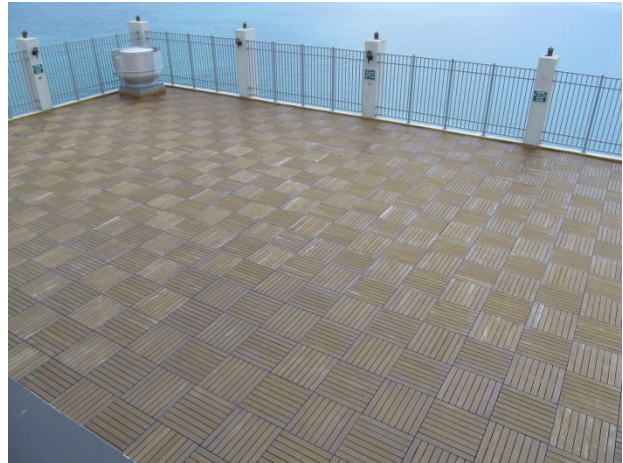
Sun deck overview

The sun deck wood and underlying roof system has a useful life of 15- to 20-years. We assume timely stain applications to the wood decking through the operating budget. We include an expenditure for replacement of the sun deck wood and roof system by 2028 and again by 2046. We note this information on Line Item 1.531 of *Reserve Expenditures*.

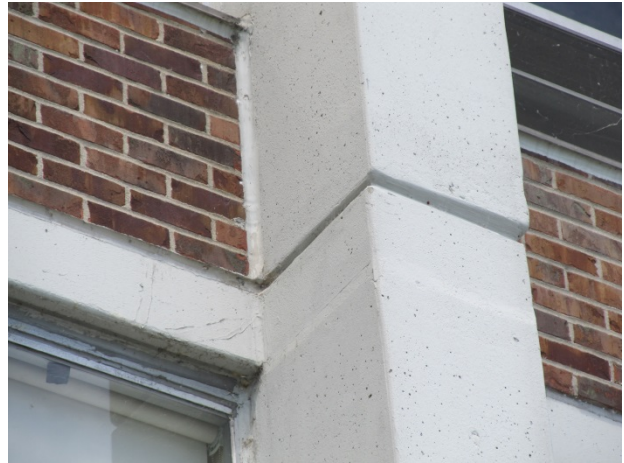
Sealant at brick/concrete interface

The periodic inspection and replacement of deteriorated sealants is essential to maximize the useful life of the window and door systems and prevent water infiltration. The Association should anticipate a useful life of up to 20 years for exterior caulk used for this application. However, the rate of deterioration of the sealants is not uniform due to the different exposures to sunlight and weather. The Association should anticipate gradual dispersed deterioration as the sealants age. We discuss solutions and procedures related to replacement of sealants in the following narrative.

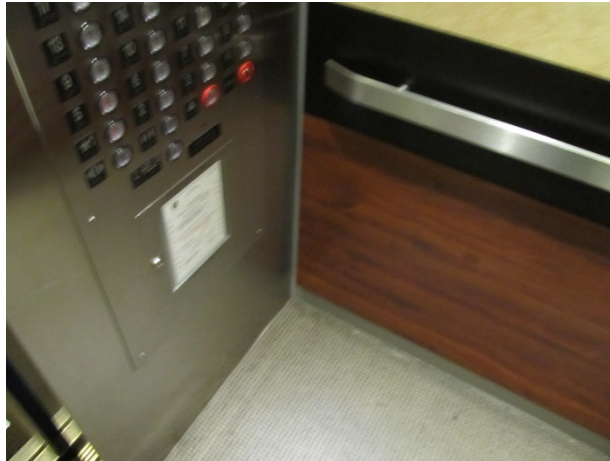
Elevator cab finishes

The finishes were replaced from 2015 to 2016. The useful life of the elevator cab finishes is up to 20 years. We recommend the Association budget for renovation of the cab finishes by 2034. We include this information on Line Item 2.100 of *Reserve Expenditures*. Granville Beach should fund interim elevator cab floor covering replacements through the operating budget.

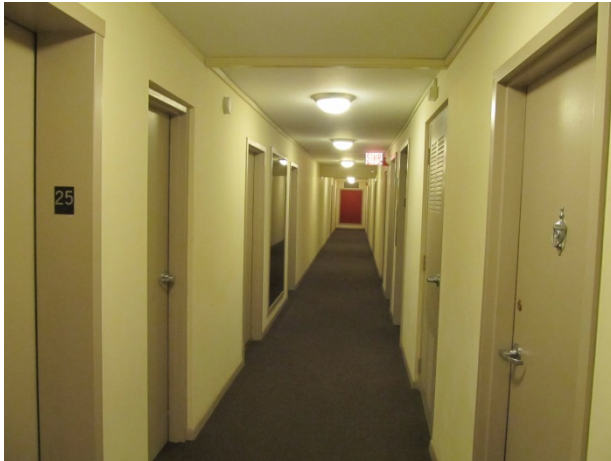
Floor Coverings, Carpet, Hallways - Carpet comprises 2,100 square yards of the common area hallway floor coverings. Contractor measurements will vary from the actual floor area due to standard roll lengths, patterns and installation waste. The carpet was replaced in 2011 and is in fair condition. We note stains and deterioration at seams.

Residential hallway

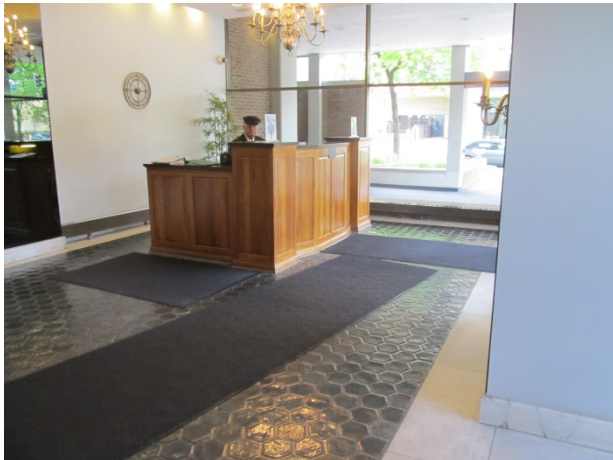
- Tile floor covering (areas of wear and damage evident)
- Paint finishes
- Doorman station
- Furnishings
- Light fixtures
- Automatic doors (three total)

Lobby

We recommend the Association anticipate a lobby renovation up to every 25 years. The lobby provides a first impression for guests and prospective buyers of condominiums.

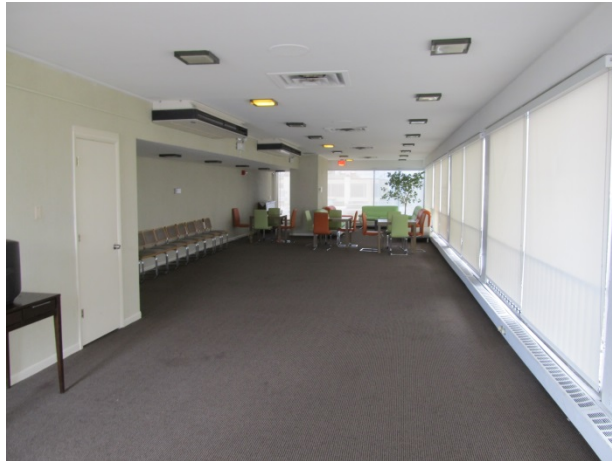
The components appear dated. We recommend renovations of the party room and 29th floor hallway up to every 20 years. The specific time of any interior renovation is somewhat discretionary and may be implemented by the Board prior to the end of its useful life. We recommend Granville Beach anticipate a party room renovation by 2021 and again by 2039. We note this information on Line Item 2.840 of *Reserve Expenditures*.

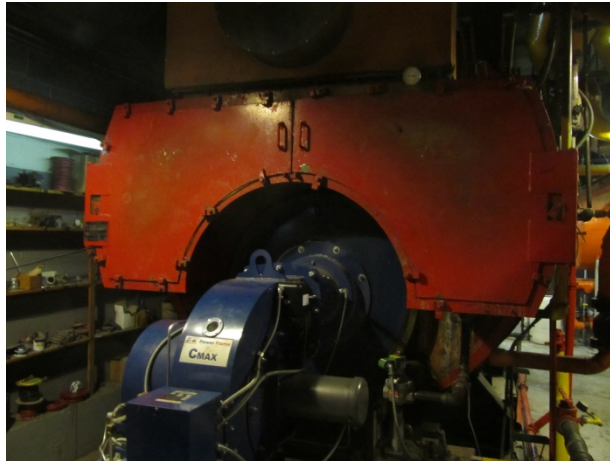
The *Elara* report dated May 24, 2016 details the existing boiler system, conditions, energy efficiency improvement opportunities and scope of recommended near term replacement. The useful life of boilers of this capacity and use is up to 50 years in our experience. Therefore, we concur with the recommendation of *Elara* to plan for near term replacement of the boiler system. We include an expenditure based on information provided by *Elara* for replacement of the boiler system by 2020. We assume the following summarized scope based on the scope provided by *Elara*:

- Replacement of the existing boilers with nine hot water boilers
- Replacement of the coils in the corridor and 29th floor air handling units
- Replacement of the building heating system pumps
- Installation secondary pumps for the garage and make-up air loop
- Conversion of the unit heaters from steam to hot water
- Installation of two new garage unit heaters
- Installation of new domestic hot water storage tank
- Replacement of the domestic hot water heat exchangers
- Replacement of the controls with digital systems and installation of a building automation system

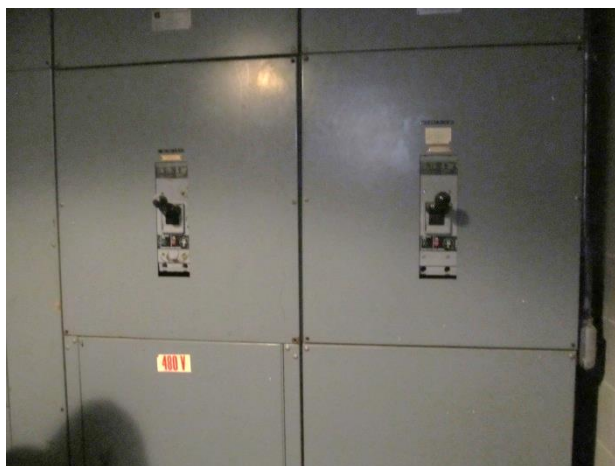
Electrical System - The electrical system at Granville Beach is primarily original to construction. Based on our conversations with the Building Engineer, the system is in reported satisfactory condition. The system includes:

Distribution panels

We recommend the Association budget to replace the main switchgear, distribution and circuit protection panels by 2036. We recognize that the Association may be required to replace the fuse type panels prior to 2036. Updates of this Reserve Study will consider possible changes in the scope and times of component replacements based on the conditions, including the need for replacement of the wires. We note this information on Line Item 3.300 of *Reserve Expenditures*.

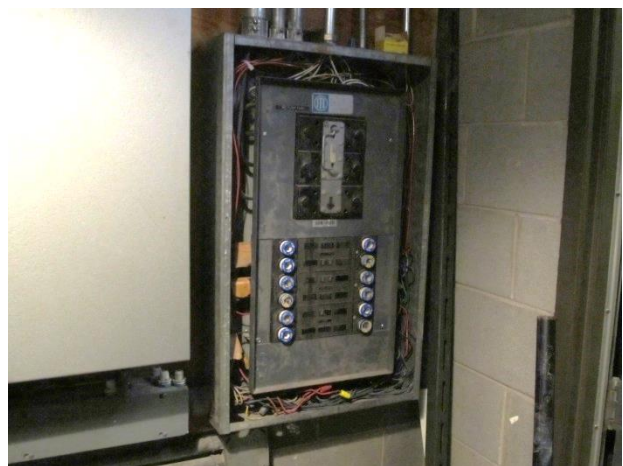
Fuse type circuit protection panel

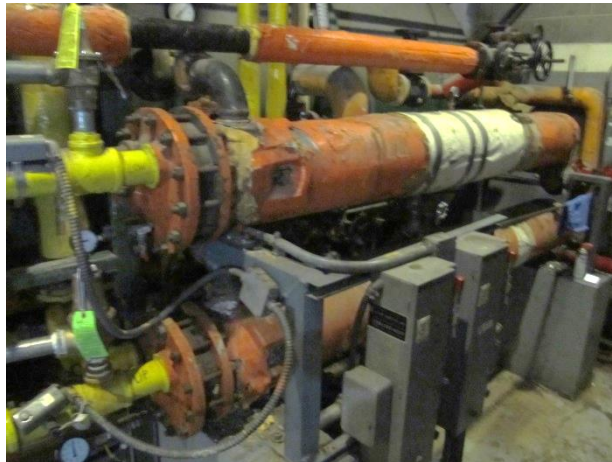
Domestic water heat exchangers

The useful life of the domestic water heat exchangers is up to 25 years. We recommend the Association budget for subsequent replacement of the domestic water heat exchangers by 2035. We note this information on Line Item 3.465 of *Reserve Expenditures*. We recommend the Association periodically inspect the heat exchangers and conduct repairs as needed from the operating budget.

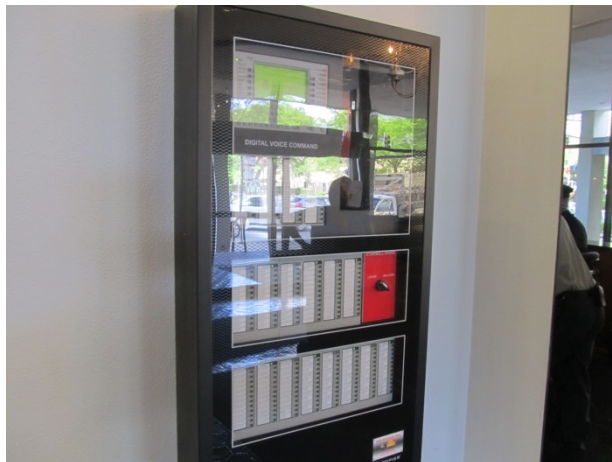
Central life safety panel

Life safety system devices have useful lives of up to 25 years with proper maintenance. Control panels have a useful life of up to 15 years. Changes in technology or building codes may make a replacement desirable prior to the end of the functional life. With consideration of the operational condition and age, we recommend the Association budget for replacement of the devices by 2037, and the control panel by 2028 and again by 2042.

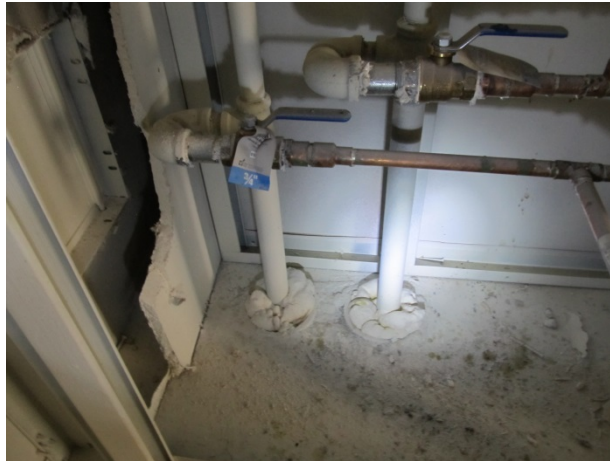
Domestic Water - The supply and return galvanized steel domestic water risers are primarily original. The Association recently replaced the rest room supply and return hot water risers at the 01, 03, 08 and 10 tiers at floors 15-17. The Building Engineers reports a history of leaks, low pressure complaints, thinning of the pipe walls and development of occlusions within the pipes.

Domestic water piping

The useful life of galvanized domestic supply and return pipes is up to and sometimes beyond 70 years. The first piping system usually to experience problems is domestic hot water. The rate of build-up varies based on flow rates, minerals in the water and temperature. Occlusions from deposits eventually develop, reduce water pressure and clog pipes. Galvanized pipe is zinc coated steel which slows oxidation or rusting. The galvanized pipe provides a surface texture for minerals such as calcium and magnesium (water hardness minerals) to adhere. These minerals build-up at a faster rate on galvanized piping when compared to copper piping. Also, corrosion of these pipes will eventually result in pitting of the interior surface and pinhole leaks. We recommend the Association budget funds to replace the galvanized water piping with copper piping. Copper piping is the predominant type of pipe used in new construction for domestic water piping.

- Building heating – phased replacement beginning by 2041 and concluding by 2045
- Domestic water, waste and vent - phased replacement beginning by 2019 and concluding by 2028

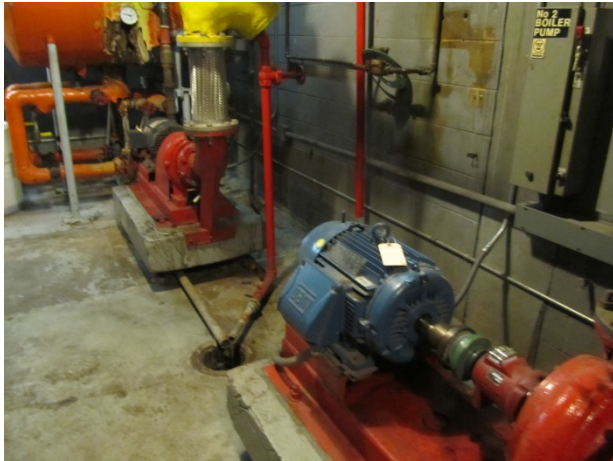
Building heating pumps

- Building Heating – subsequent replacement by 2041
- Domestic Cold Water - replacement by 2036
- Fire Suppression - replacement by 2028
- Gas Booster - replacement by 2020 and again by 2041
- Sump/Sewage Ejection - replacement by 2020 and again by 2038

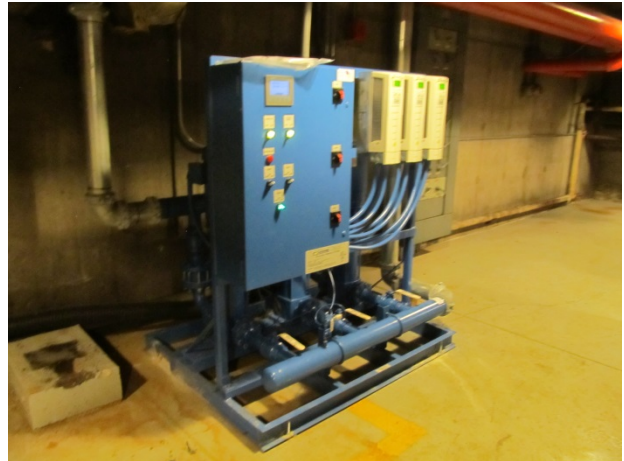
Domestic cold water pumps

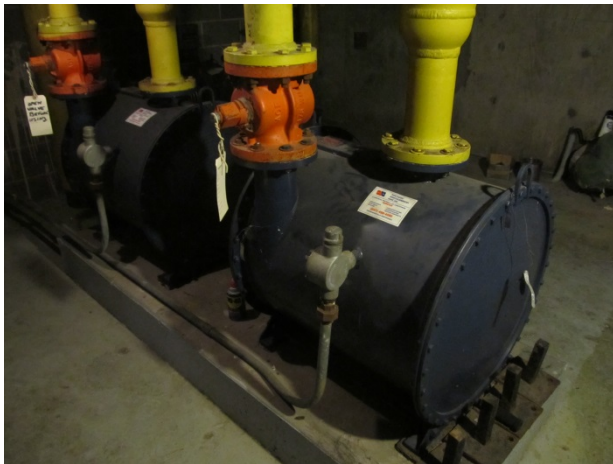
Gas booster pumps

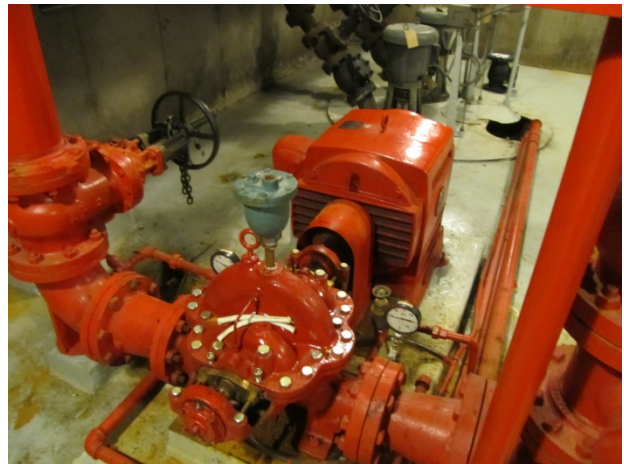
Fire suppression pump

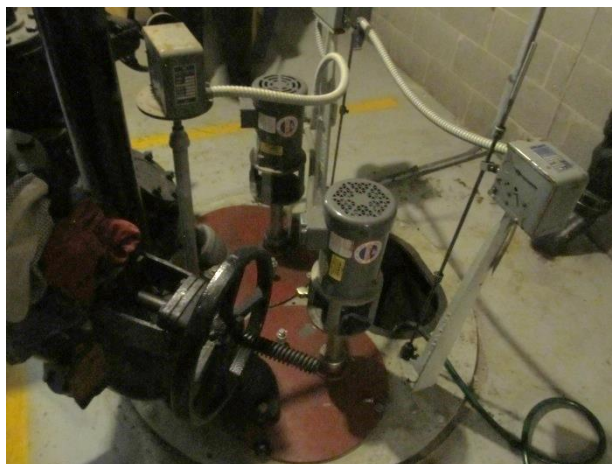
Sump/sewage ejection pumps

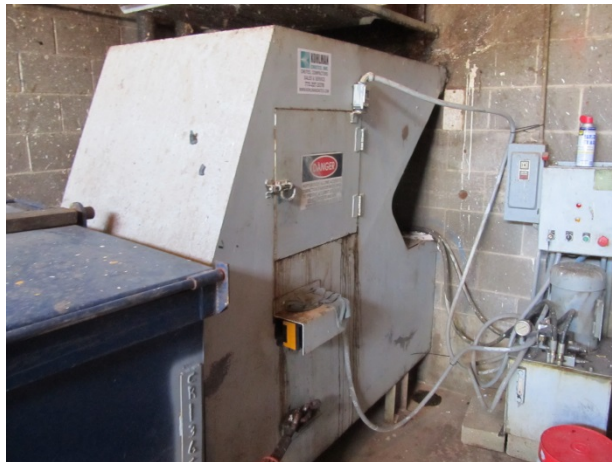
The compactor was installed in 1997, is reported in satisfactory condition and has a useful life of up to 25 years. We recommend the Association plan for replacement by 2019 and again by 2041. We note this information on Line Item 3.900 of *Reserve Expenditures*.

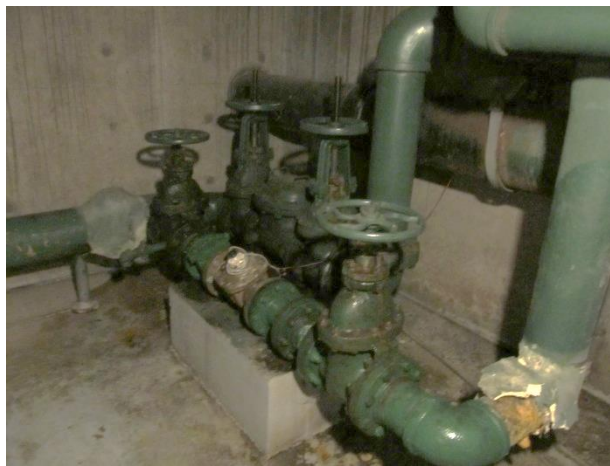
Valves at main water connection

The valves are primarily original. As the valves age, seals will deteriorate and mineral deposits will limit their operation. Large valves have a useful life of up to and sometimes beyond 50 years. We recommend the Association anticipate replacement by 2020. We include this information on Line Item 3.920 of *Reserve Expenditures*. The Association should replace or repair all remaining valves as needed and fund this ongoing maintenance activity through the operating budget.

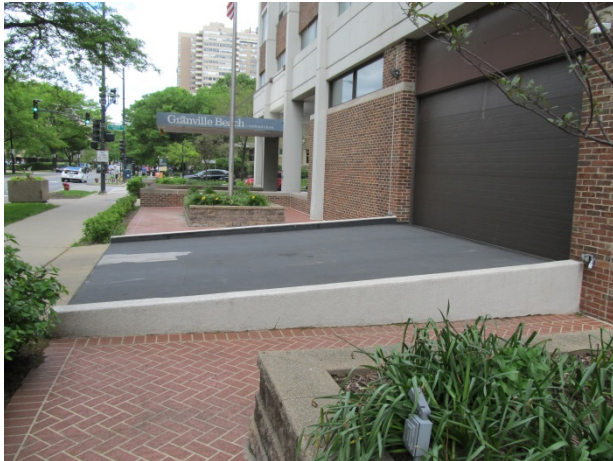
The concrete exhibits areas of cracks and deterioration. The ceiling beneath the elevated areas exhibits evidence of water infiltration.

Vaulted systems at west perimeter

We recommend the Association budget for the following interim repairs by 2019 and again by 2039:

- Replacement of perimeter sealants
- Concrete crack repairs and patching
- Surface coating application (including traffic coating at pavement)
- Replacement of a limited amount of underlying membrane

We also recommend the Association plan to repair the concrete structure as necessary, and replace the membrane and all previously listed elements by 2029. We note this information on Line Items 4.959 and 4.960 of *Reserve Expenditures*.

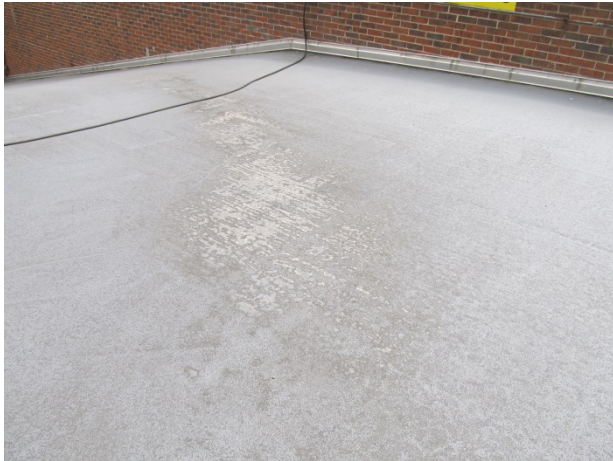
Traffic coating west at 2nd floor

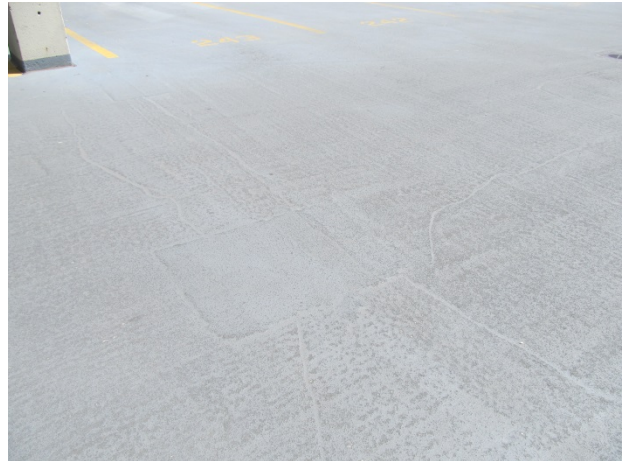
Traffic coating west at 2nd floor

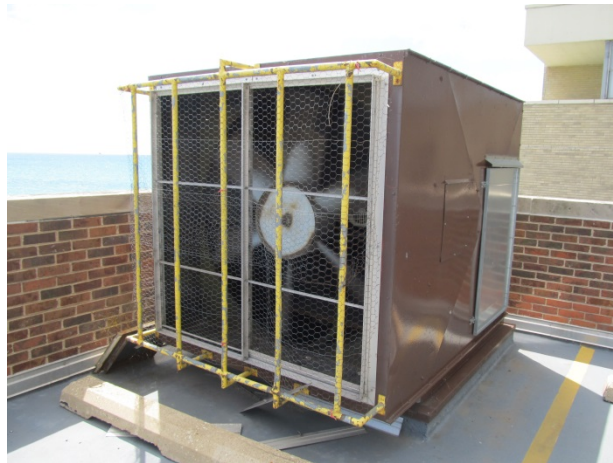
Garage exhaust fan

The fan is possibly original and has a useful life of up to 30 years. The system lacks operational control through an integral carbon monoxide detection system. We recommend the Association budget for replacement of the system, including installation of an integral carbon monoxide detection system to improve energy efficiency, by 2020. We regard interim repairs or partial replacements of exhaust system components as normal maintenance. We note this information on Line Item 7.460 of *Reserve Expenditures*.

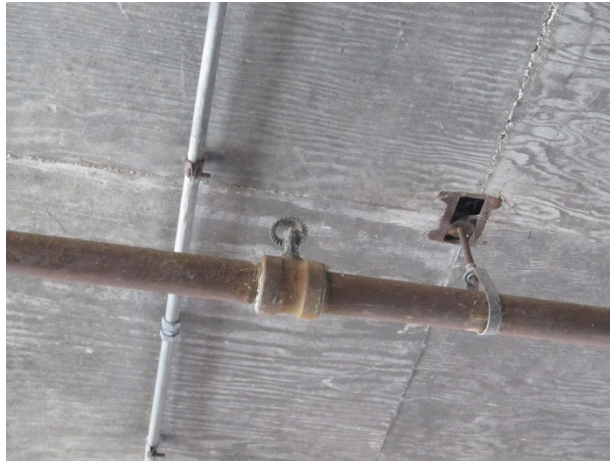
Fire sprinkler system head

Proper operation of the fire suppression system in the event of a fire requires unobstructed sprinkler heads. The Association should keep the sprinkler heads and pipes free of ornamentations and coverings. Granville Beach should verify as normal maintenance that all sprinkler pipes remain on independent hangers.

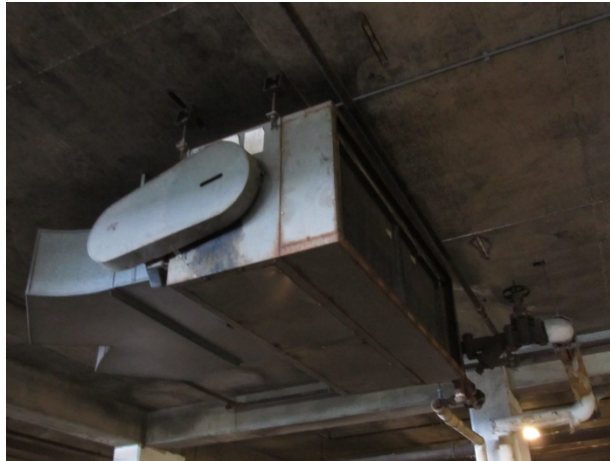
Garage unit heater

The unit heaters are likely original. The useful life of large capacity unit heaters is up to 30 years. Based on the age and condition of the unit heaters, we recommend the Association budget for complete replacement of all unit heaters by 2020 concurrent with the boiler system project. We note this information on Line Item 7.900 of *Reserve Expenditures*.
