**Revised**  
**FULL RESERVE STUDY**  
**Circle C**  
**Homeowners Association**

**Austin, Texas**

**Inspected - May 29, 2018**  
**Revised - September 21, 2018**

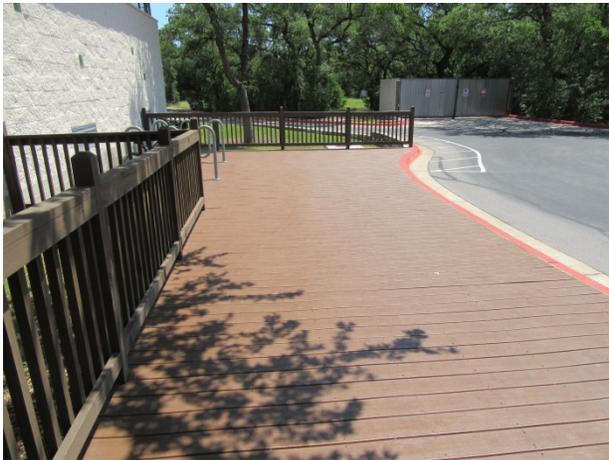
**Condition:** Good overall with sags and dips evident

Deck overview

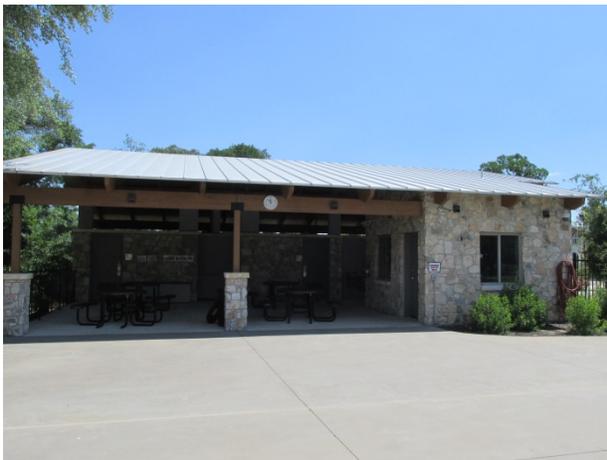
**Condition:** Good to fair overall with no significant deterioration evident. Management does not report a history of leaks.

**Metal roof at amenity center**

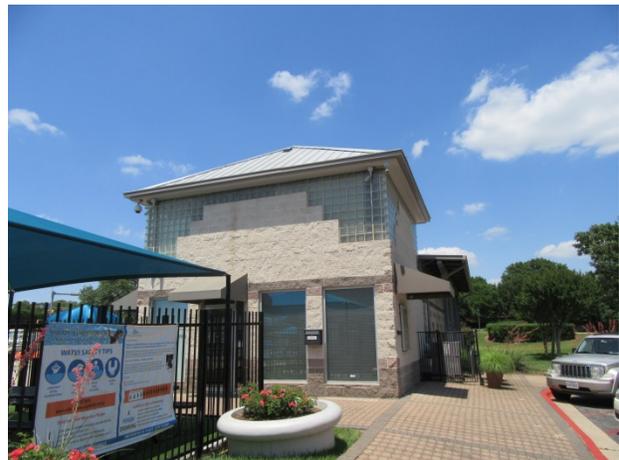
**Metal roof at Swim Center lifeguard building**

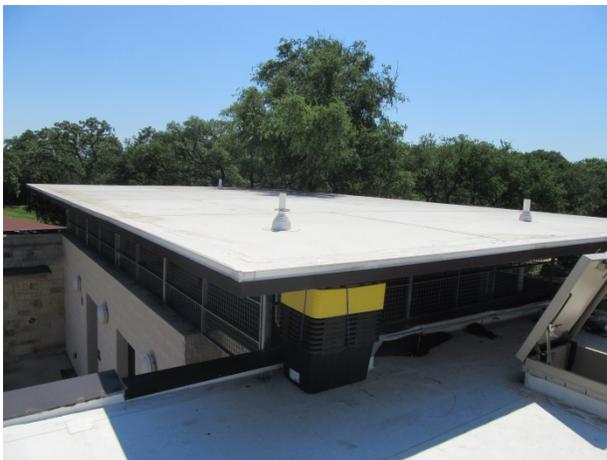
**Condition:** Good to fair overall with bulges in the membrane evident at the Community Center.

**Thermoplastic roof overview**

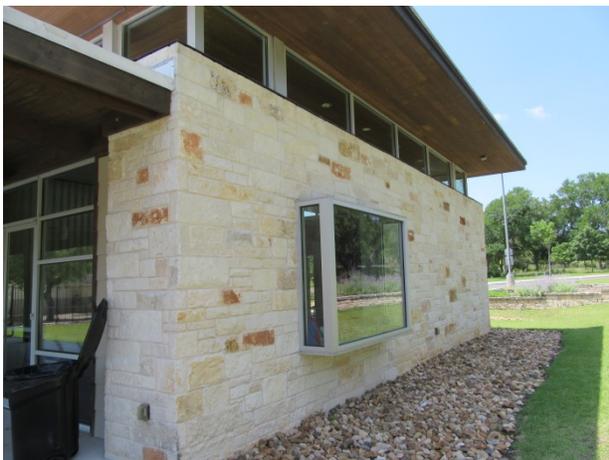
**Stone masonry at Community Center**

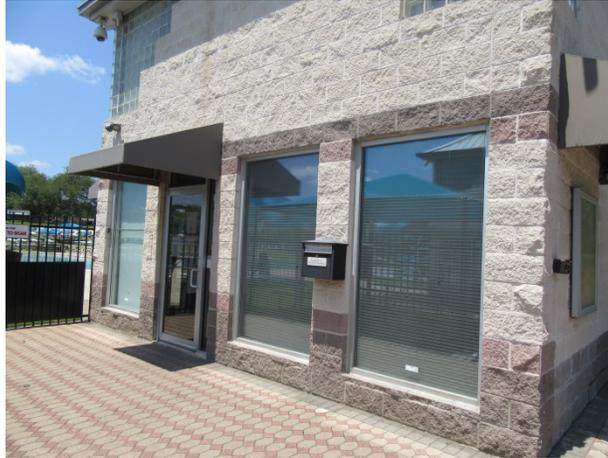
**Condition:** Fair overall

**Windows and door**

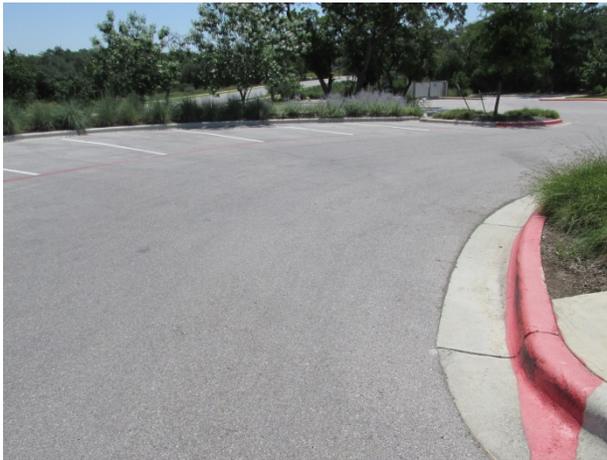
**Condition:** Good to fair overall with seal coat deterioration throughout the locations and fatigue cracks and previous repairs at the Swim Center evident

**Asphalt pavement overview at Avana**

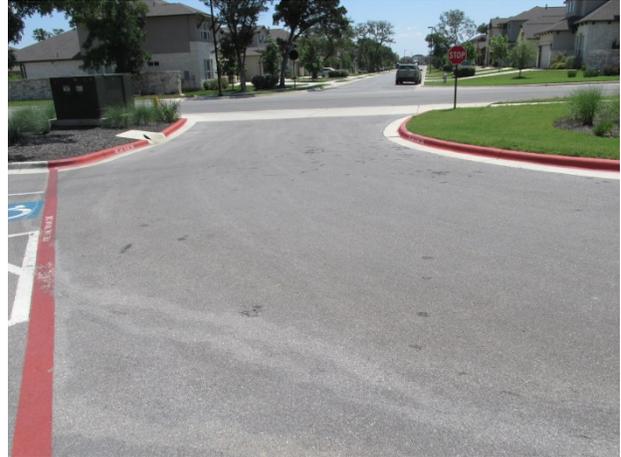
**Asphalt pavement overview at Grey Rock**

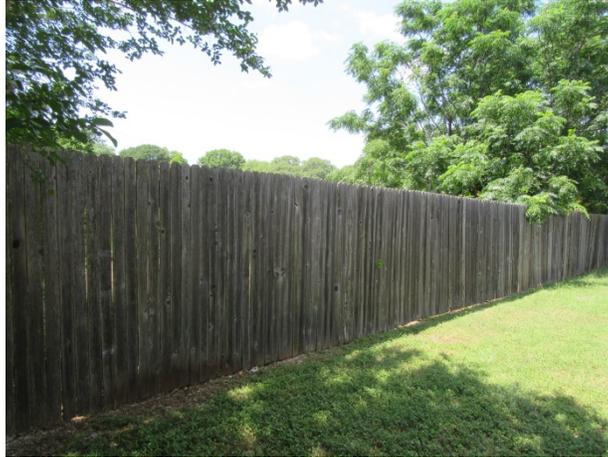
**Condition:** Fair overall

**Wood fence**

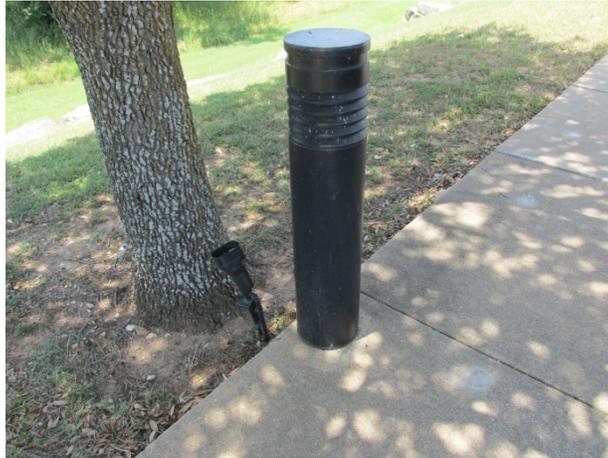
**Condition:** Fair overall

**Bollard and landscape light fixture**

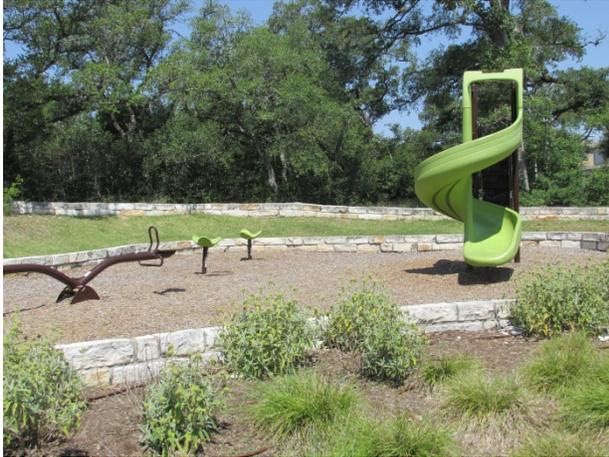
**Condition:** Good to fair overall

**Equipment at Avana**

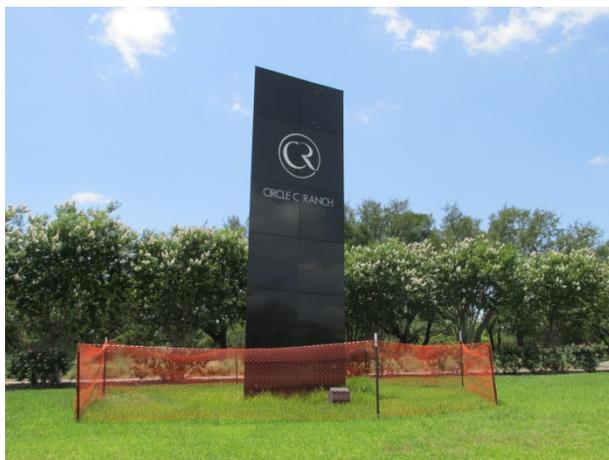
**Condition:** Good overall, with reported concerns at the main entrance monument.

**Main entrance monument**

**Expenditure Detail Notes:** Expenditure timing and costs are depicted in the **Reserve Expenditures** table in Section 3. The 2019 expenditure is for remedial repairs to the main entrance monument.

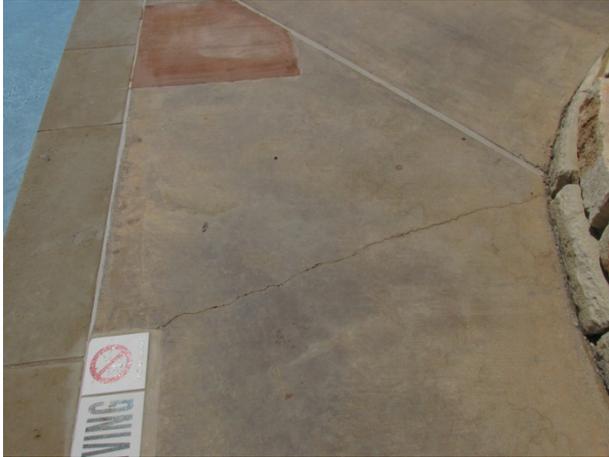
**Condition:** Good condition overall. The decks at Avana and Grey Rock are uncoated, the deck at the Community Center primarily is coated, with a limited section that is not, and the Swim Center deck is primarily masonry pavers with a limited amount of uncoated concrete.

**Deck at Avana**

- Selective cut out and replacements of up to ten percent (10%) of concrete
- Crack repairs as needed
- Mortar joint repairs
- Caulk replacement
- Coating replacement at currently coated locations
- Removal of the pavers with partial resetting and replacement

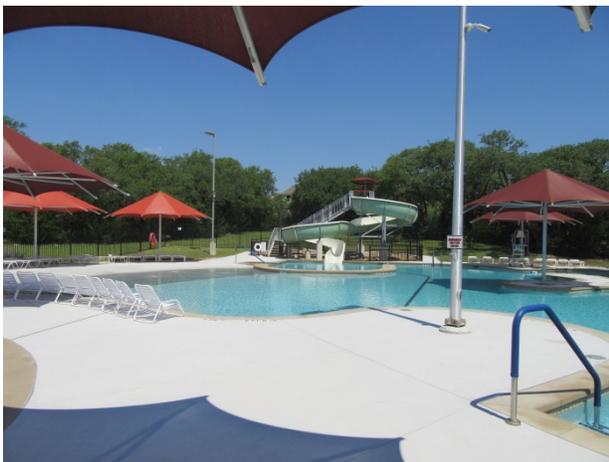
**Coated deck at the Community Center**

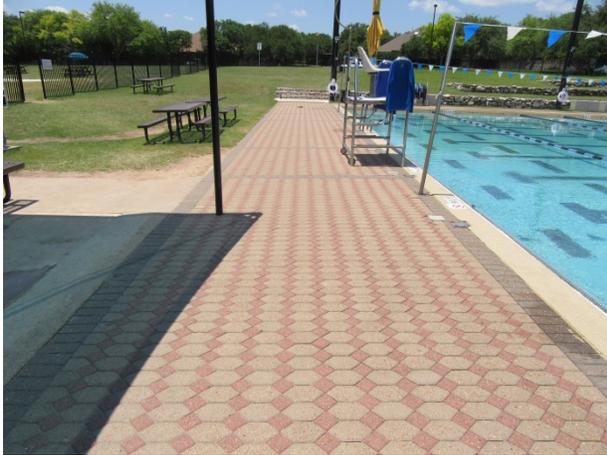
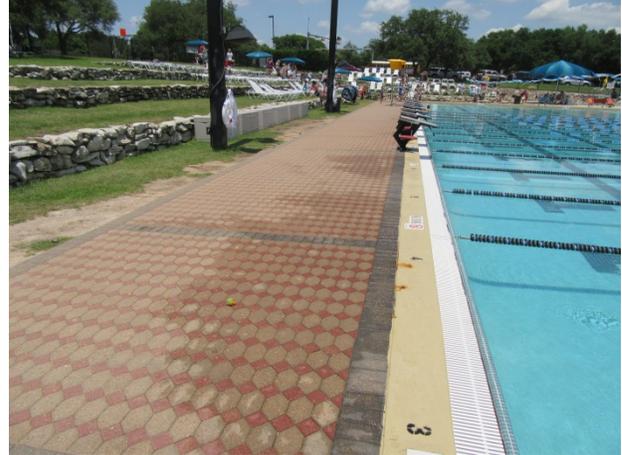
**Pavers at the Swim Center**

**Useful Life:** The useful life of a concrete pool deck is up to 60 years or more with timely repairs. We recommend the Association conduct inspections, partial replacements and repairs to the decks at Avana, the Community Center and Grey Rock every 8- to 12-years. The masonry pavers at the Swim Center have a useful life of up to 25 years. We recommend the Association coordinate repairs to the concrete deck portion concurrent with resetting and partial replacement of the masonry pavers every 8- to 12-years.

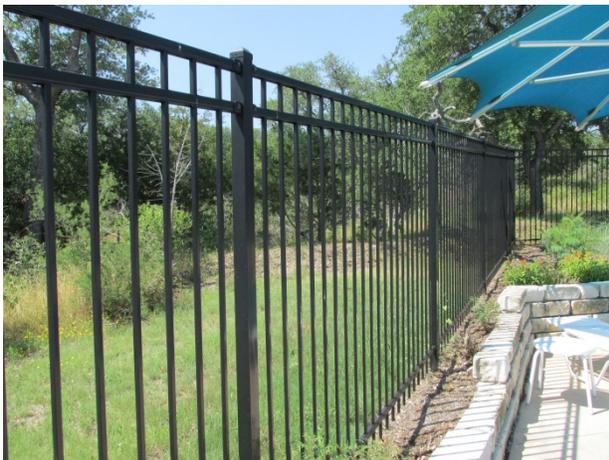
**Condition:** Good overall condition with isolated areas of rust and damage evident

**Fence at Avana**

**Expenditure Detail Notes:** Expenditure timing and costs are depicted in the **Reserve Expenditures** table in Section 3. We recommend the Association budget for paint finish applications through the operating budget.

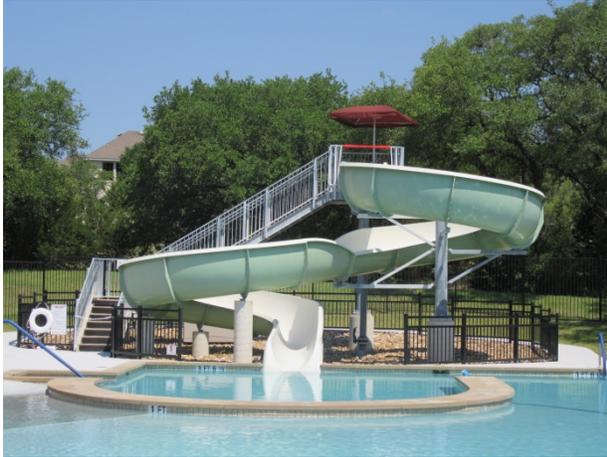
**Conditions:** Good overall with evidence of rust and minor deterioration

**Slide overview**

**Component Detail Notes:** Safety is the major purpose for maintaining the water slide. We recommend an annual inspection of the water slide to identify and repair as normal maintenance loose connections and fasteners or damaged elements. We recommend the use of a specialist for the design or replacement of the water slide environment.

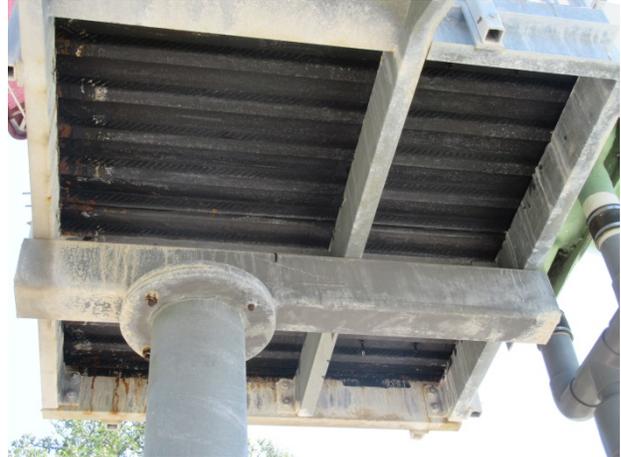
**Support structure**

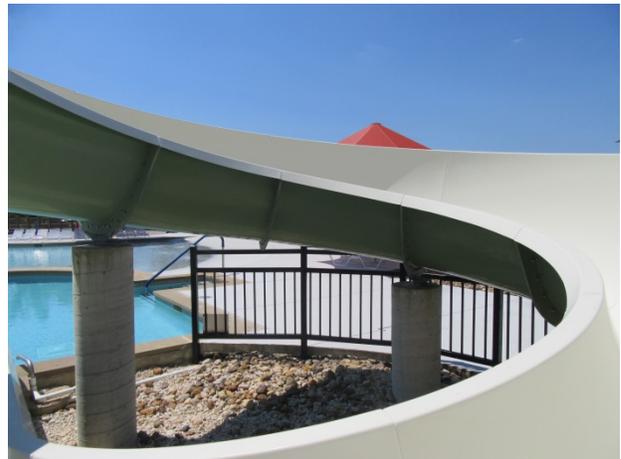
**Slide overview**

**Useful Life:** Replacement at up to 20 years and refinishing every five years
