# **FULL RESERVE STUDY**

## **Sunvalley Casitas Condominium Association**

**Mesa, Arizona**  
**January 3, 2022**

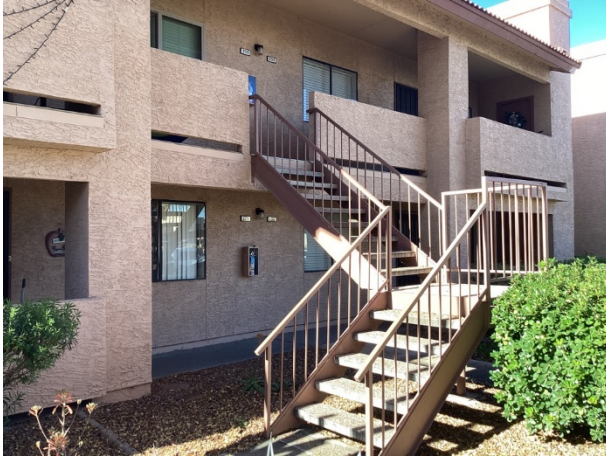
**Staircase and larger breezeway**

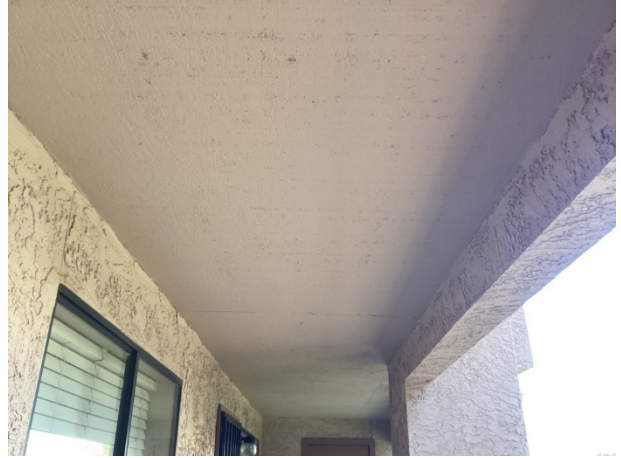
**Underside of breezeway**

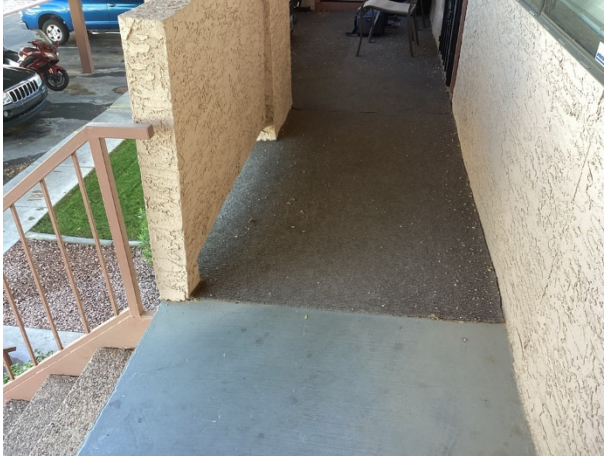
**Condition:** Good to fair overall with isolated deterioration evident. We note limited locations of carpet at the breezeways added by homeowners. Carpet conceals concrete deterioration, retains water and inhibits drainage. Water trapped by the carpet can result in accelerated concrete deterioration. Therefore, we do not recommend the use of carpet on breezeway surfaces.

**Partial carpet floor covering**

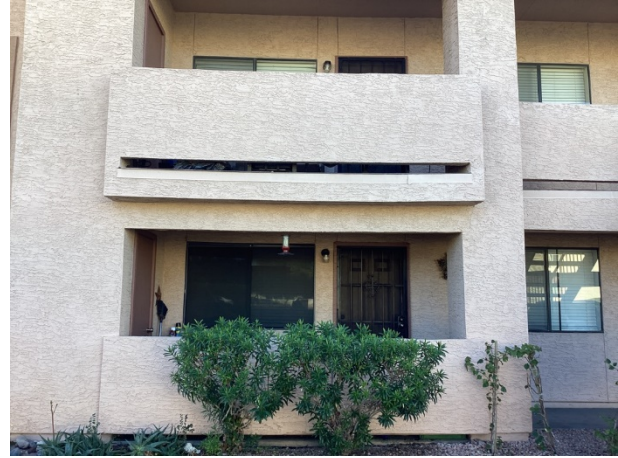
**Possible deflection at Building 5, note this location has carpet present**

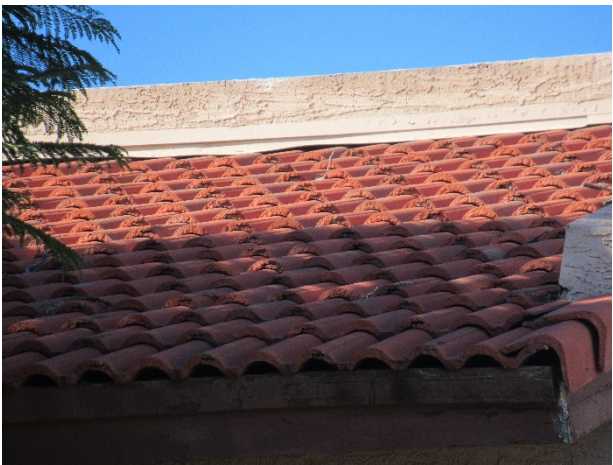
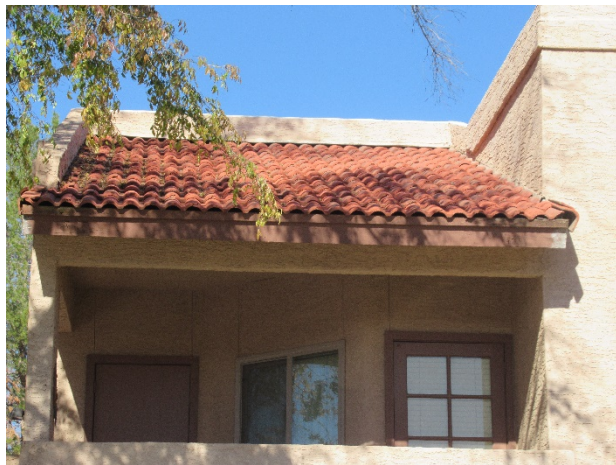
**Condition:** Fair overall with previous repairs, and chipped and loose tiles evident from our visual inspection from the ground. Management and the Board report a limited history of leaks and inform us the Association will obtain bids to replace in the near future.

**Tile roof overview**

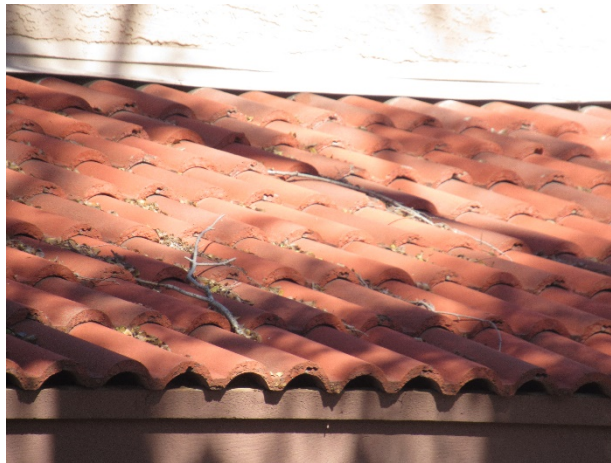
**Vegetation debris**

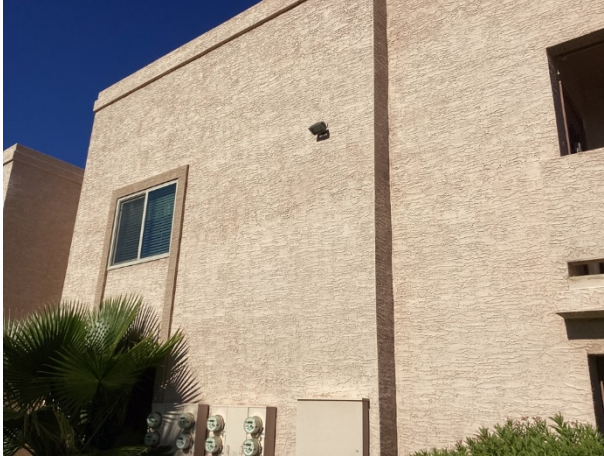
**Condition:** Fair overall with cracks, coating deterioration and finish stains evident.

**Stucco wall finishes**

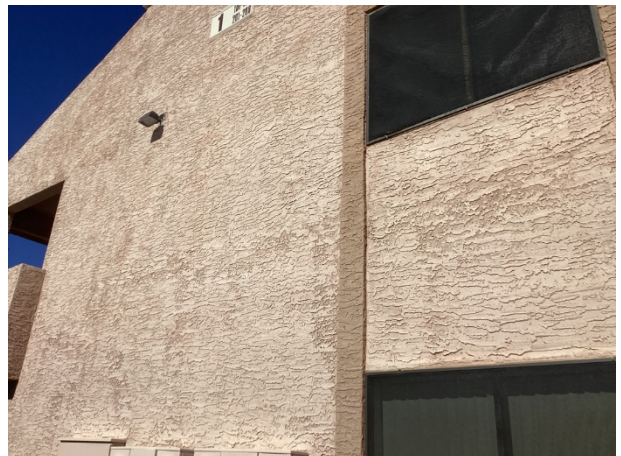
**General fade at south facing elevation**

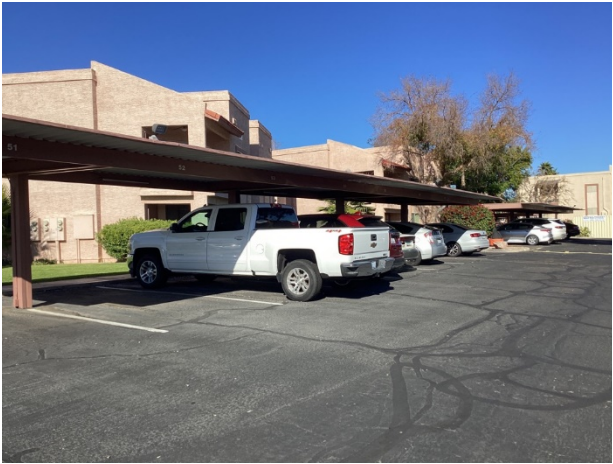
**Condition:** Good to fair overall with isolated damage and rust evident

**Carports**

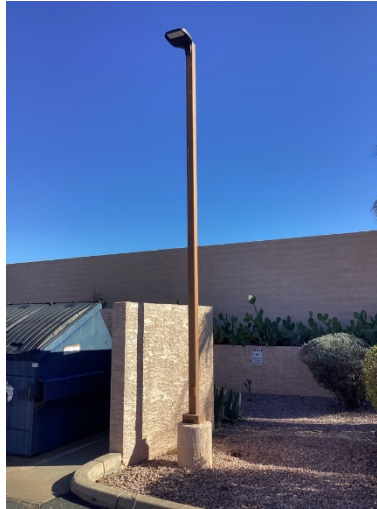
**Condition:** Good to fair overall with finish deterioration evident.

**Light pole and fixture**

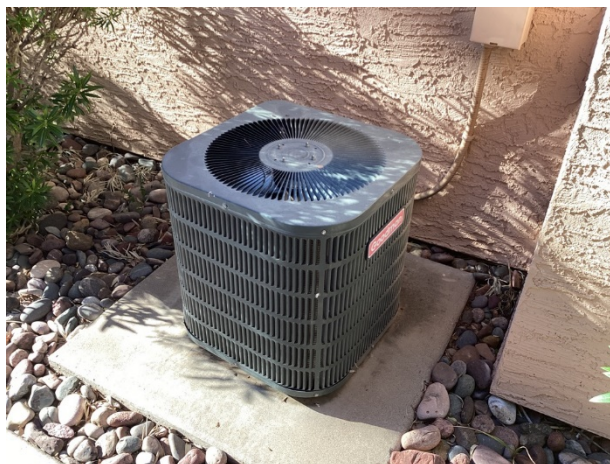
**History:** The age was unavailable at the time of our inspection though the system is likely more than 15 years of age.

**Condition:** Reported satisfactory without operational deficiencies

Split system condensing unit

**Expenditure Detail Notes:** Expenditure timing and costs are depicted in the **Reserve Expenditures** table in Section 3. The condensing unit may require replacement prior to replacement of the related interior forced air unit. For purposes of this Reserve Study, we assume coordination of replacement of the interior forced air unit, evaporator coil, refrigerant lines and exterior condensing unit.

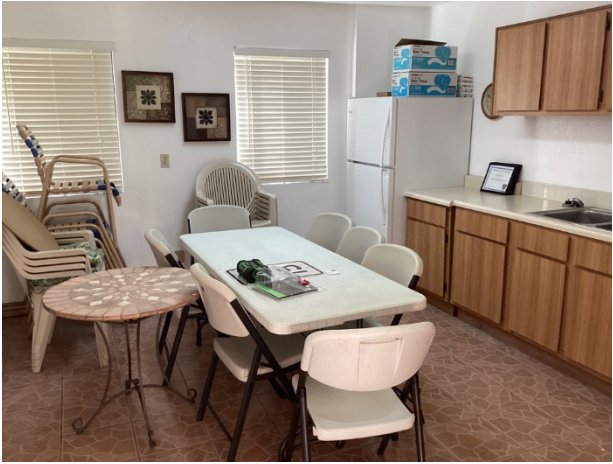
**History:** Ages vary though the finishes appear primarily dated.

**Condition:** Fair overall

**Cabana interior**

**Expenditure Detail Notes:** Expenditure timing and costs are depicted in the **Reserve Expenditures** table in Section 3. We recommend interim renovations and paint finishes are funded through the operating budget.

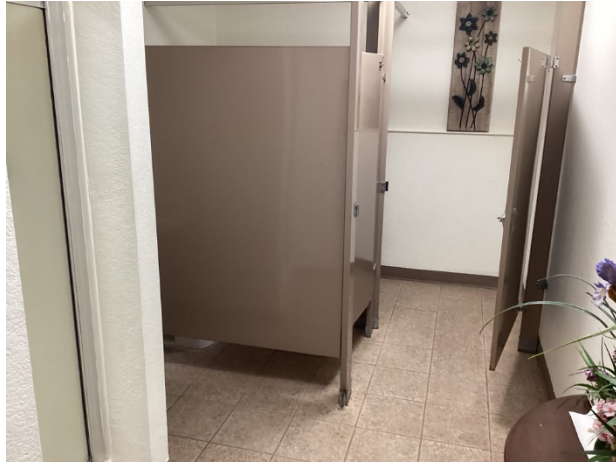
**Rest room**

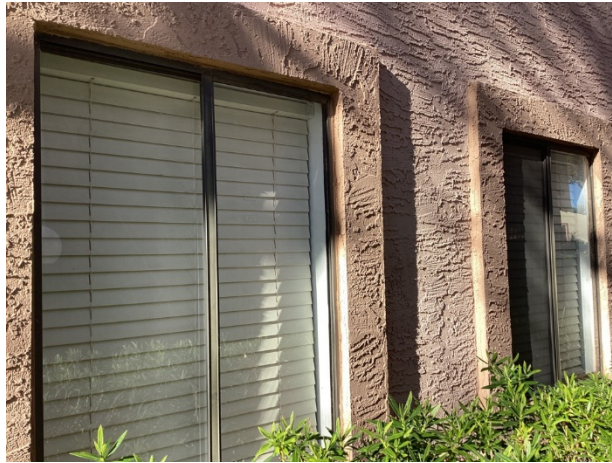
**History:** Original.

**Condition:** Good to fair condition

**Cabana aluminum frame windows**

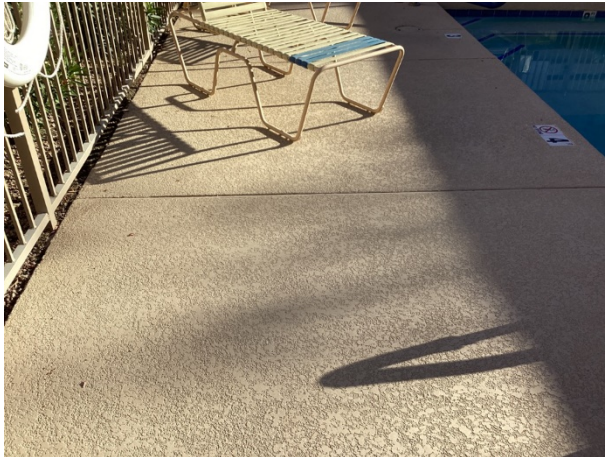
**History:** Inspected and repaired, or coating applied, in 2019.

**Condition:** Good overall with isolated cracks and coating deterioration evident

Pool deck coating

**Expenditure Detail Notes:** Expenditure timing and costs are depicted in the **Reserve Expenditures** table in Section 3. We recommend the Association budget for the following per event:

- Selective cut out and replacements of up to ten percent (10%) of concrete
- Crack repairs as needed
- Mortar joint repairs
- Caulk replacement
- Coating replacement

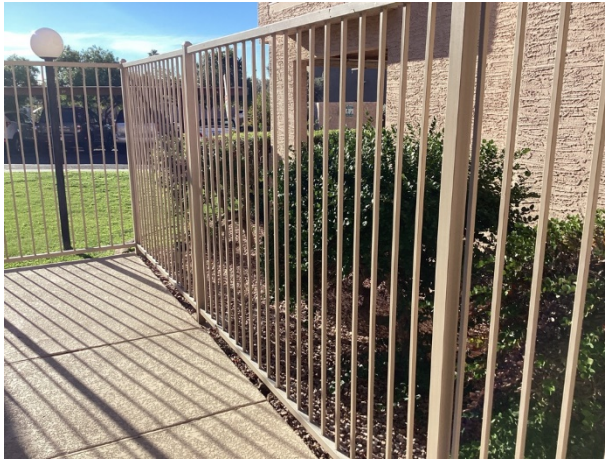
**History:** Original.

**Condition:** Good to fair overall with periodic rust evident.

**Steel pool fence**

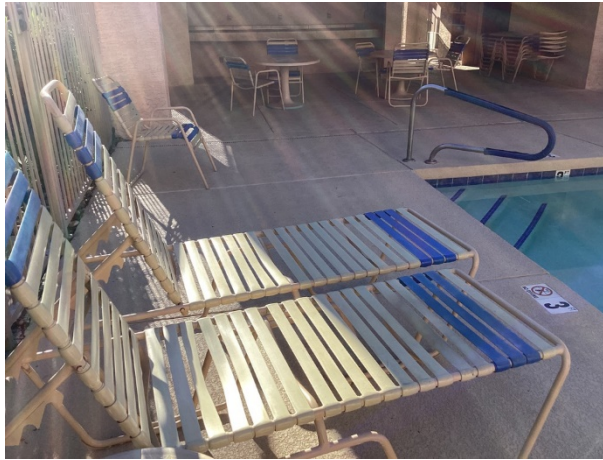
**History:** Replaced in approximately 2014.

**Condition:** Good to fair overall

**Pool furniture**

**Expenditure Detail Notes:** Expenditure timing and costs are depicted in the **Reserve Expenditures** table in Section 3. We recommend interim re-strapping, refinishing, cushion replacements, reupholstering and other repairs to the furniture as normal maintenance to maximize its useful life.

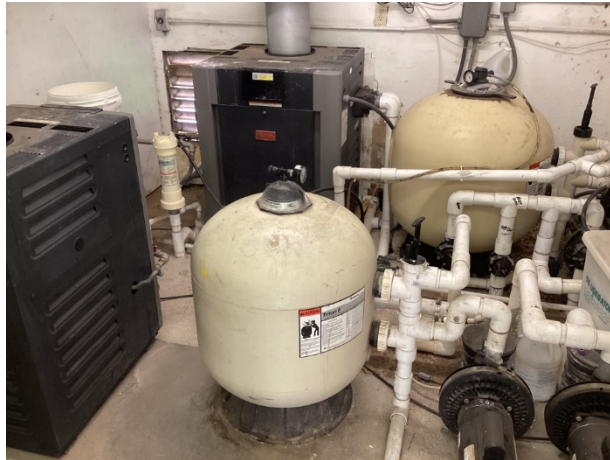
**History:** Age varies.

**Condition:** Reported satisfactory without operational deficiencies

**Pool mechanical equipment**

**Expenditure Detail Notes:** Expenditure timing and costs are depicted in the **Reserve Expenditures** table in Section 3. Failure of the pool mechanical equipment as a single event is unlikely. Therefore, we include replacement of up to fifty percent (50%) of the equipment per event. We consider interim replacement of motors and minor repairs as normal maintenance.
